Phase One Environmental Site Assessment 179 Mellanby Avenue & 48 and 56 Main Street West, Port Colborne

179 Mellanby Avenue, 48 & 56 Main Street West Port Colborne, ON L3K 3T9

> Date: October 14th, 2022 NSSL File No.: NS2290-01

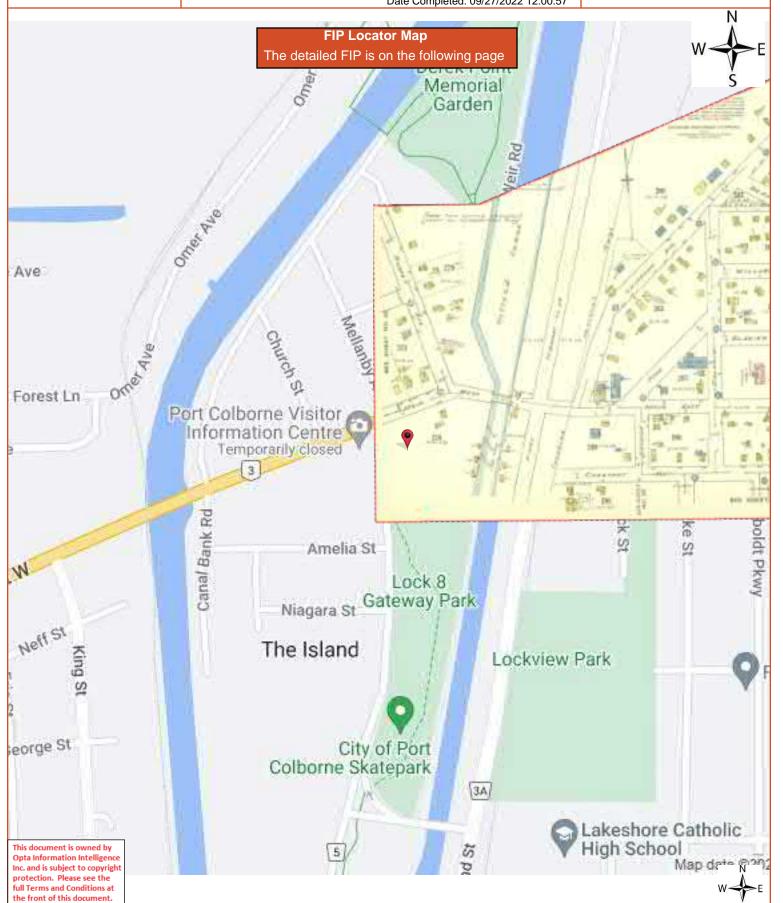
1953 Volume: Port Colborne Firemap: 33 Port Colborne Plan: 1563 (1953) Sheet: 33 (1953)

No changes were noted on the 1953 FIP for the three [3] study site properties as compared to the 1939 plan. The adjacent surrounding properties are depicted as roadways, vacant lot, and the previously mentioned UST. This FIP portrays the entire study area as mostly residential with some commercial and

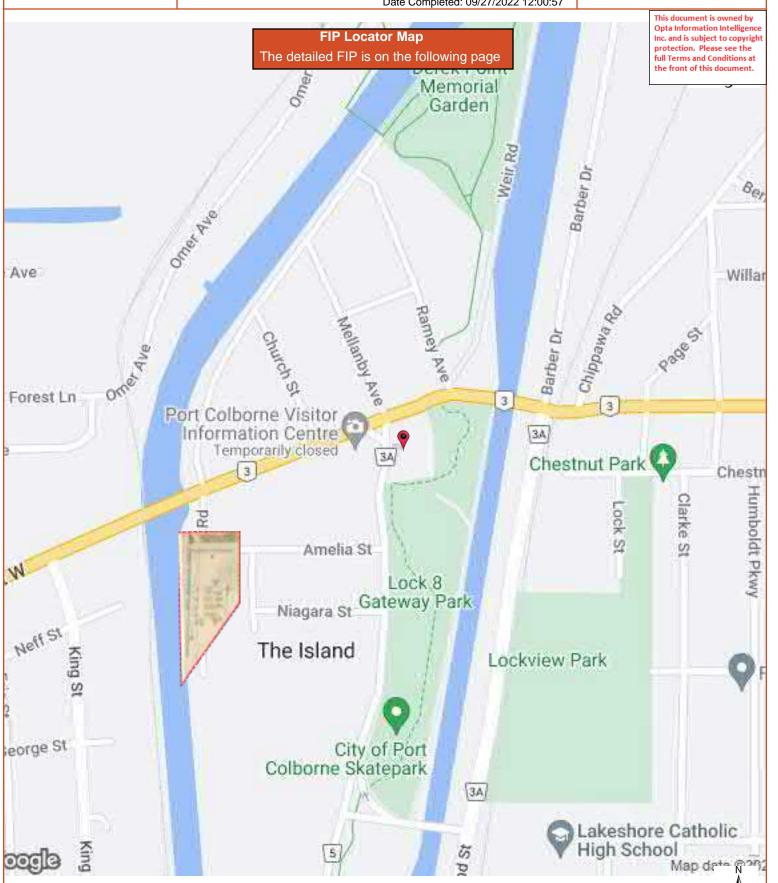
1939 Volume: HUMBERSTONE Firemap: 3 Humberstone Plan: 913 A (1926) Sheet: 3 (1939)

The 1939 plan depicted all three [3] properties with residential dwellings and detached storage garages. The one garage at 179 Mellanby Avenue was labelled as a paint shop. The northern and western portion of the study area is noted as predominantly residential with various commercial properties, however, no additional details regarding the southern and eastern portions were illustrated. Other features depicted on the FIPs identified vacant lots to the south, one [1] UST within the roadway on Mellanby Avenue [west of 179 Mellanby property line]. The paint shop and UST are Potentially Contaminating Activities that result in on-site Areas of Potential Environmental Concern to the study site. Six [6] additional PCAs were identified on the FIP including three [3] USTs, a gasoline service station, a boiler shop, and a waste oil building, however, these did not result in on-site APECs due to the distance away from the site and inferred groundwater flow direction. No other significant features were identified regarding potential environmental concerns within the study area.

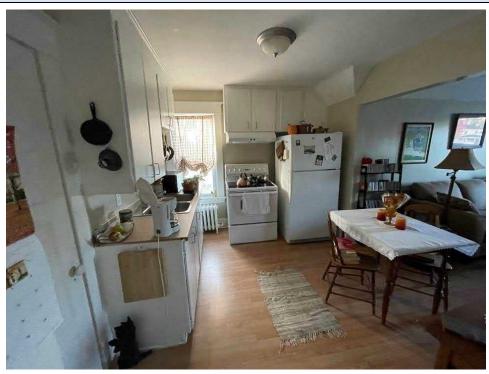
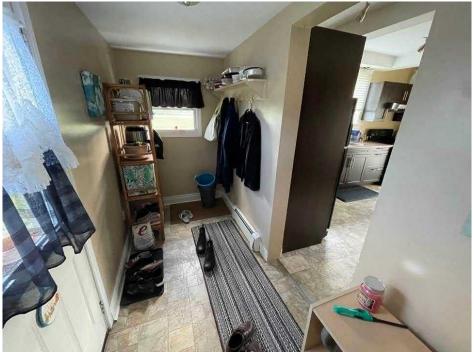
Photograph Nos. 7 & 8 – Interior view of 179 Mellanby Avenue on the main and second floor. Complete renovation of interior building materials was noted to have occurred in the early 2010s. The historic heating source was confirmed to be hot water radiator.

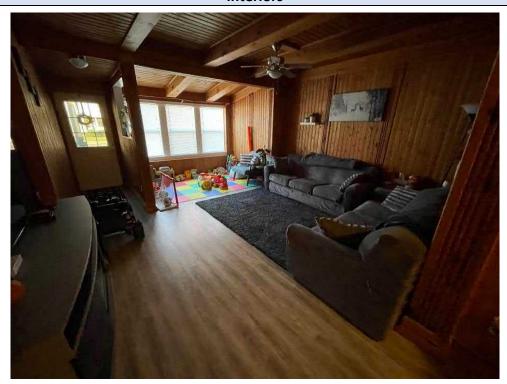
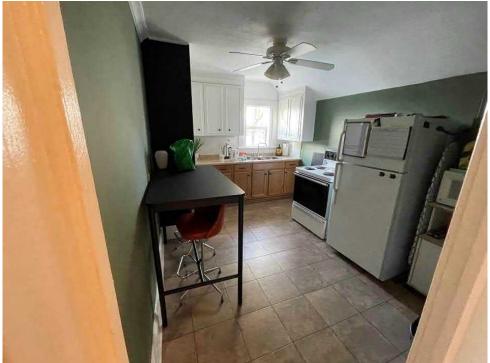
Photograph Nos. 9 & 10 – Interior view of 56 Main Street West on the main and second floor. Partial renovation of interior building materials was noted in the late 2000s. Select areas of original drywall were noted during the site inspection. The historic heating source was not confirmed.
