HERITAGE IMPACT ASSESSMENT REPORT

547 King Street, Port Colborne

Project No. 25343

Date December.09.2025

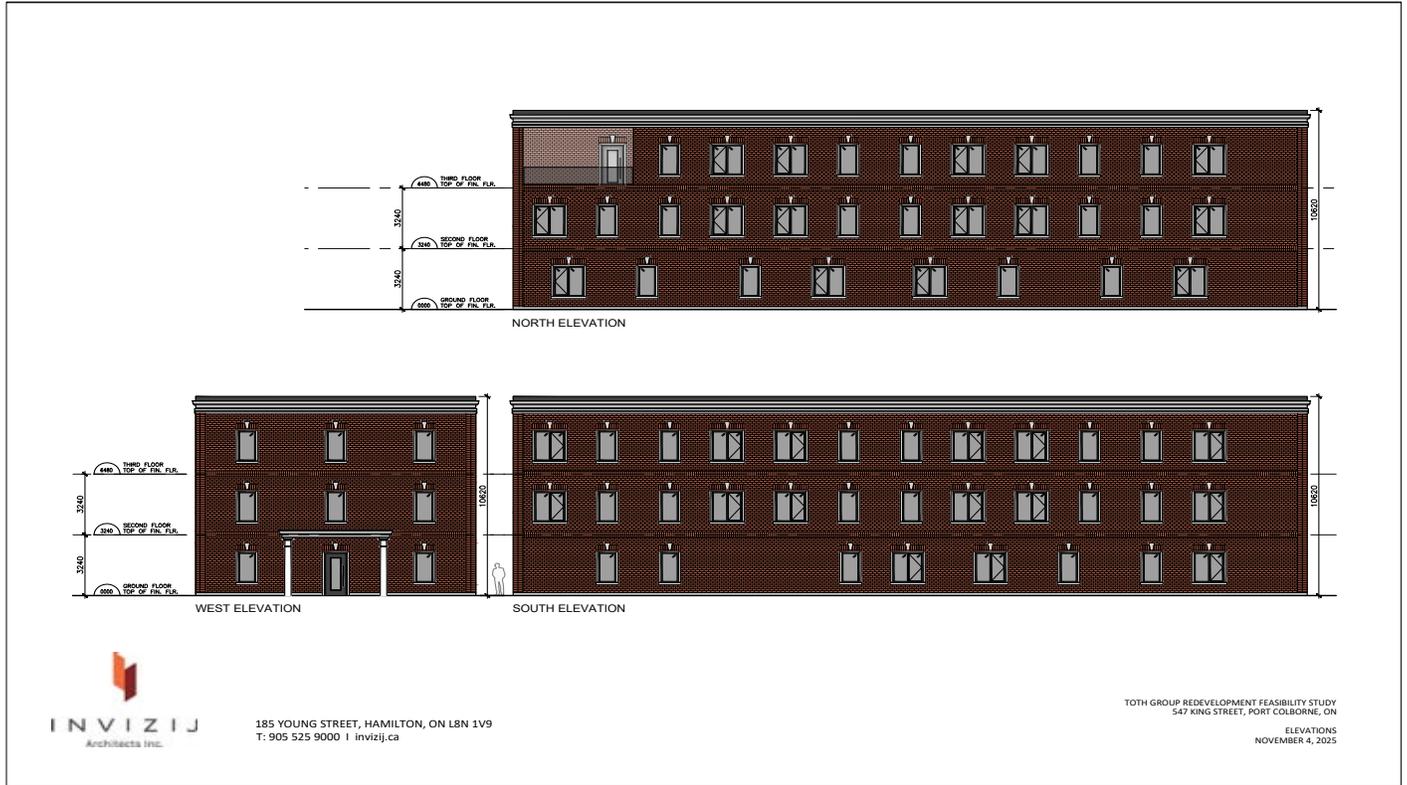
Figure 10. **Front and Side Elevations**

The new building is proposed to be constructed of red brick. The front façade of the building features symmetrically placed window and door openings with a centrally located front entranceway that will be covered by a portico. The portico features two columns that frame the entranceway. The building features brick ornamentation including brick voussoirs and keystones above windows and doorways. The side façades of the building feature a combination of single and paired windows with the same brick ornamental details.

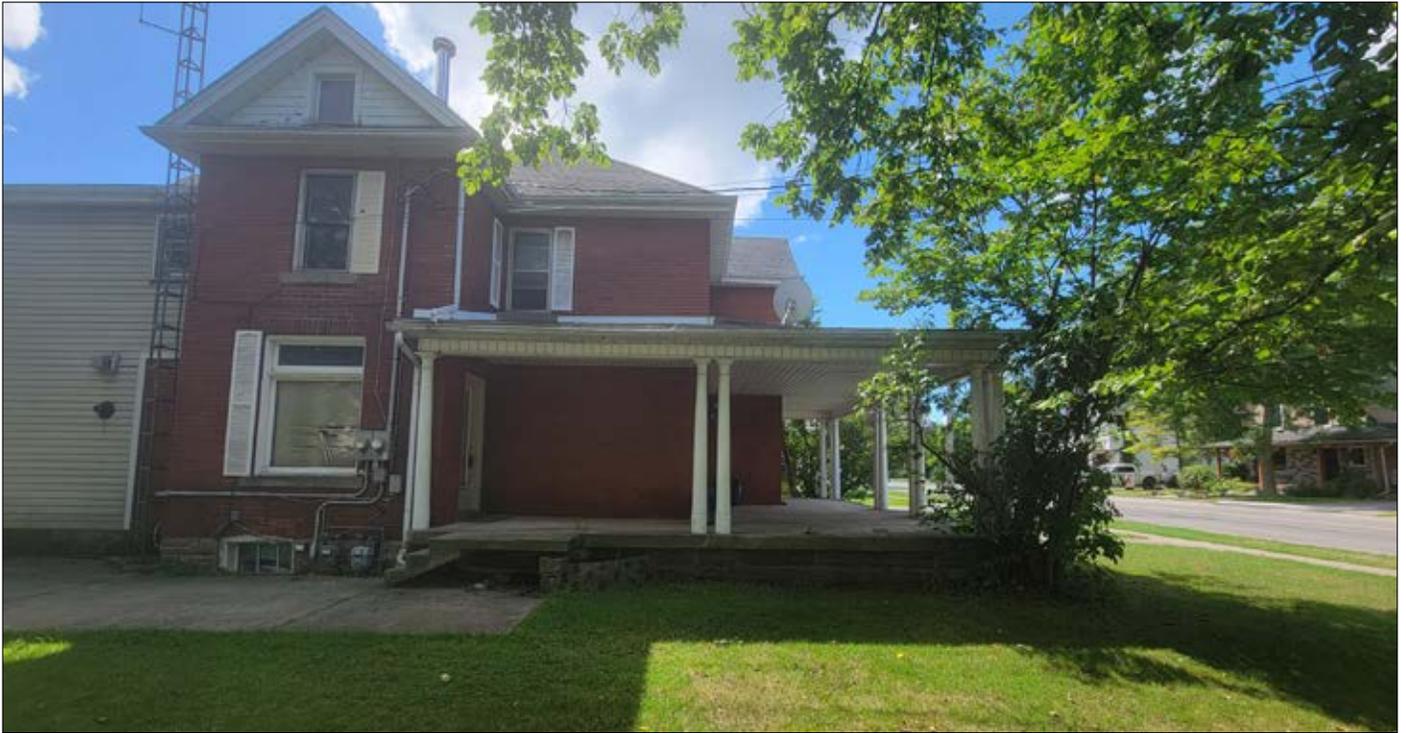
Figure 26. **North (Side) Elevation of Original Dwelling**

The north (side) elevation of the original portion of the dwelling is two and a half storeys in height. The original portion of the dwelling is clad in redbrick masonry. There is a front gable that is oriented northwards. The frontmost portion of the façade is stepped back to accommodate the secondary entrance and wraparound porch. There are four three windows located on the original portion of the north façade of the dwelling. There is a larger first storey window with a smaller transom window located above it. This window is missing a shutter which may be due to the installation of utility infrastructure on the side of the building. The transom window features stained-glass glazing. There are two second storey windows, one located above the front porch and the second located below the roof gable. Both second storey windows are single-hung sash window.

The window located above the porch has an asymmetrically oriented window shutter. The window located below the roof gable is missing a shutter. There is a single third storey (attic) window located in the roof gable that has been boarded up.

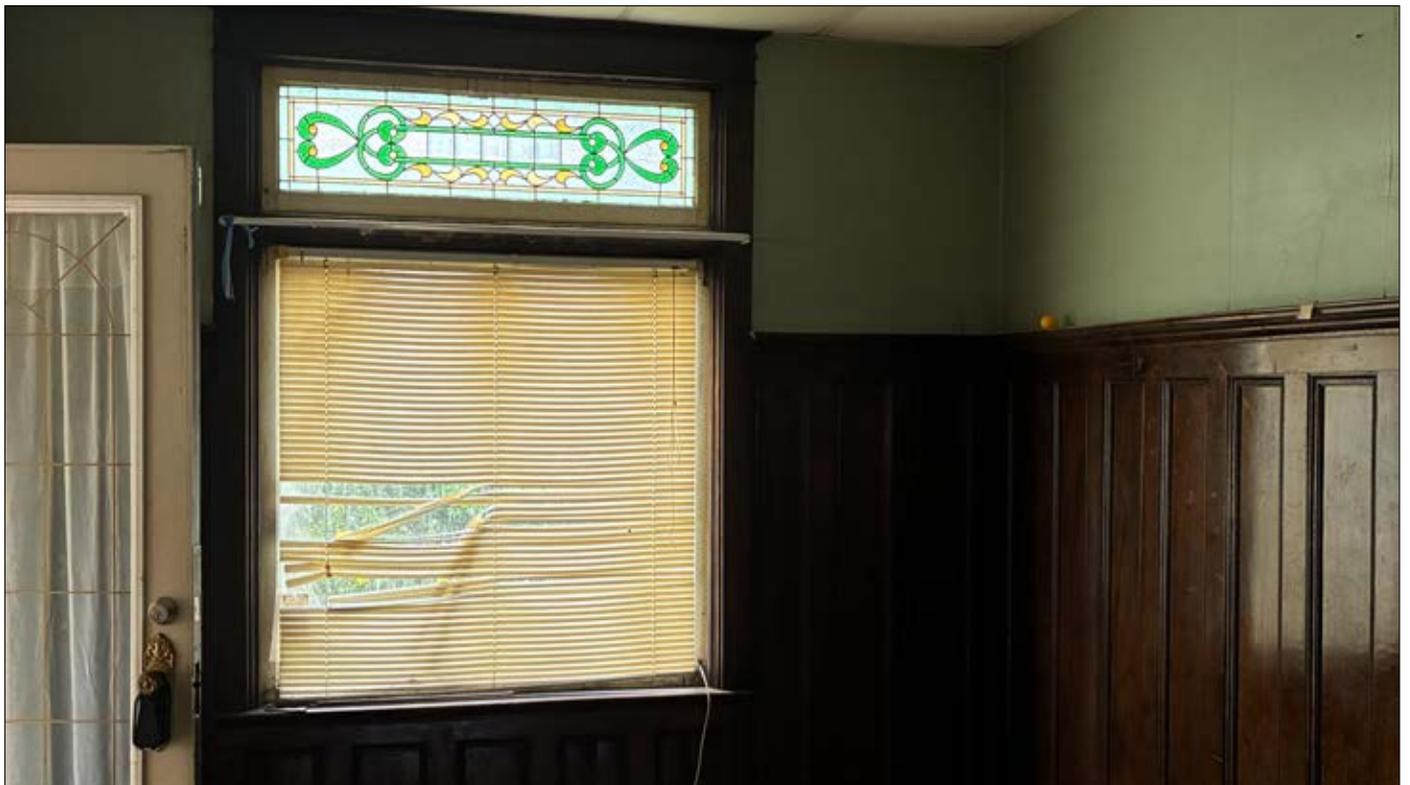
Figure 33. **Stained-glass Window and Wainscoting by Secondary Entrance**

The first floor of the building houses a residential apartment unit. The secondary front entrance of the building walks into a living/dining room. This room features a large window with a stained-glass transom located above it. A parallel window with a stained-glass transom is located on the opposite side of the dwelling. The walls feature dark wooden moulding that covers approximately two thirds of the wall height. The same decorative wooden moulding has also been used for the doors and window frames on the first floor. Some of the rooms on the first floor of the apartment feature flooring that appears to be original to the dwelling, while some feature vinyl tiling.

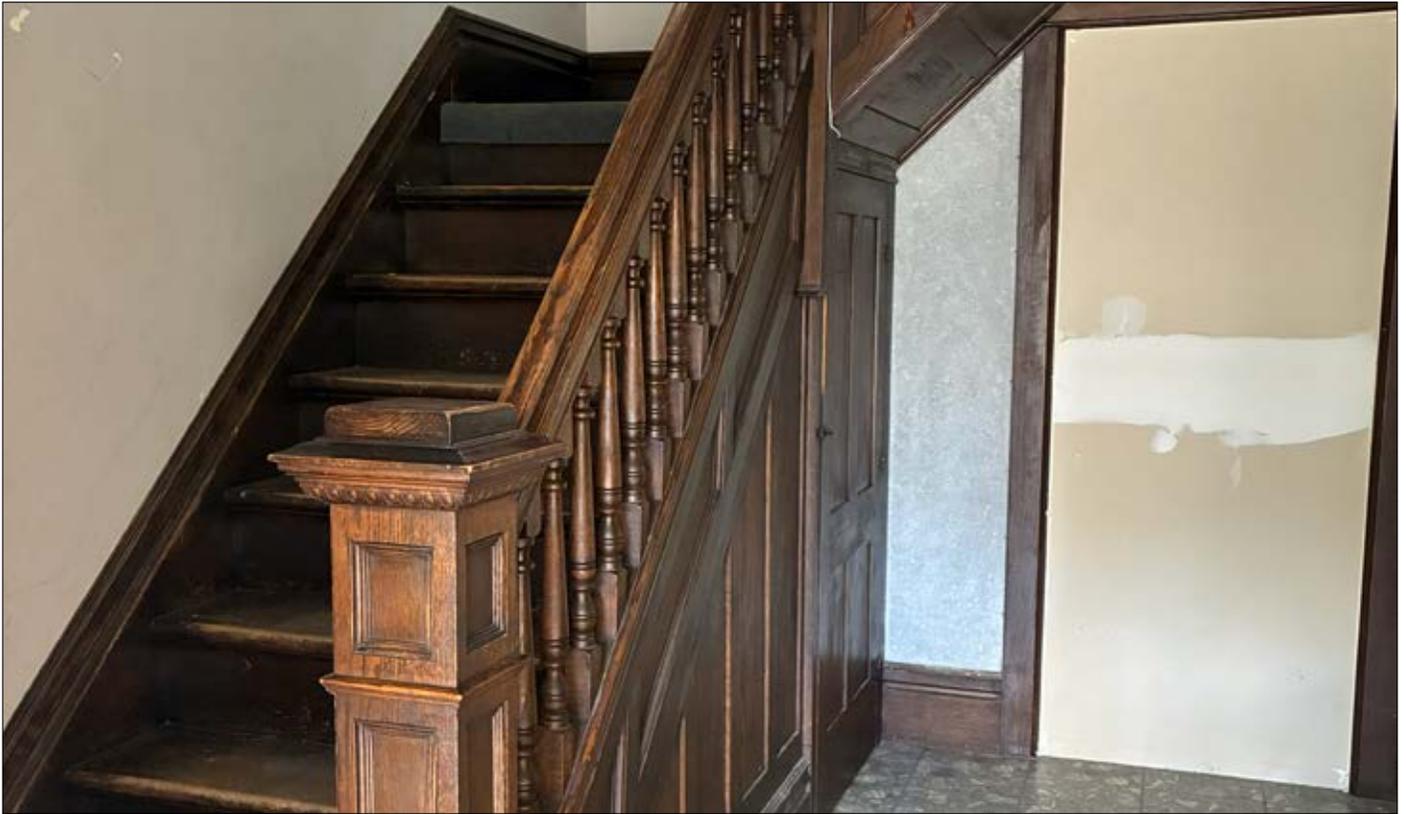
Figure 36. **Wooden staircase in primary entrance**

The front main entrance of the dwelling has been converted such that it only provides access to the apartment unit located on the second floor of the building. It features a wooden staircase that leads to the second floor. The staircase is constructed completely out of dark wood and features decorative wooden newels, balusters, handrails and panelling. The treads and risers of the staircase show significant wear from use.

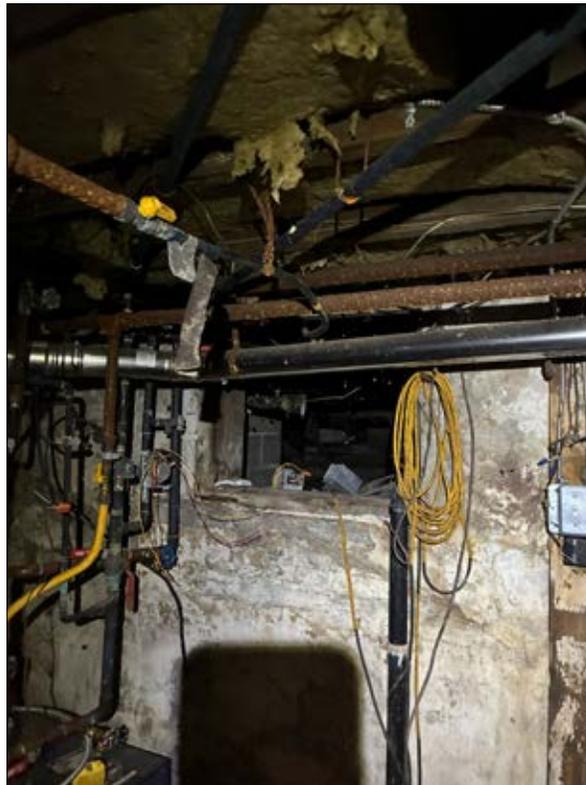
Figure 41. **Foundation and Services**

The cellar/basement of the dwelling is unfinished and contains a hot water heater and sump pump, among other services for the building. The foundation of the dwelling is visible in the cellar/basement and is constructed out of concrete block (addition) and brick.

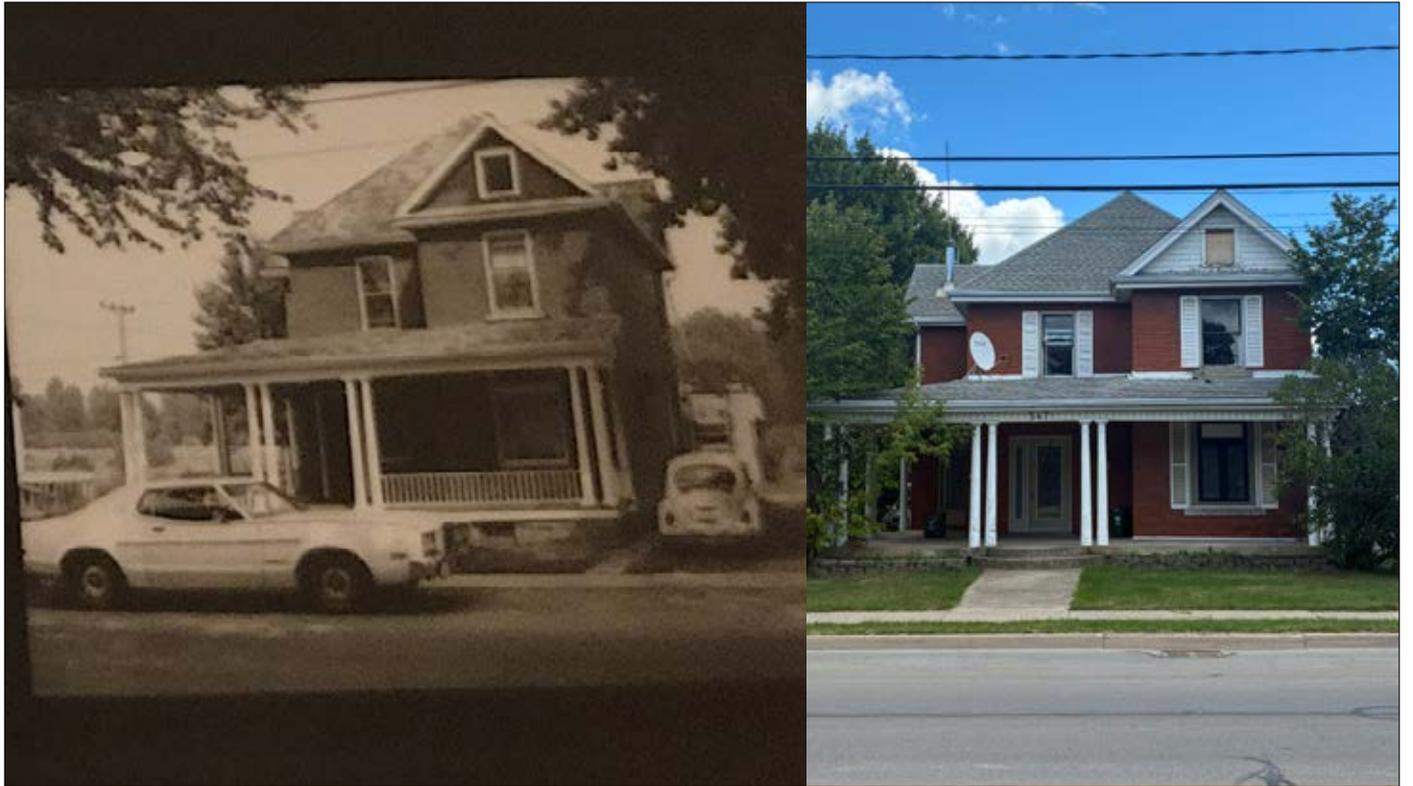
Figure 43. **A Historic Image of Dwelling, Circa Mid 1970s and Present Day Image of the Dwelling, 2025**

<ul style="list-style-type: none"> ■ Based on a historical image of the building, the window shutters are a more recent addition.
<ul style="list-style-type: none"> ■ The verandah base and its roof structure have been replaced as it covers one of the second storey windowsills. The concrete slab that forms the base of the front porch replaced an earlier porch which is visible in the historic photograph. The paired columns that support the roof over the front porch appear to have been retained through the renovation based on the historical photograph.

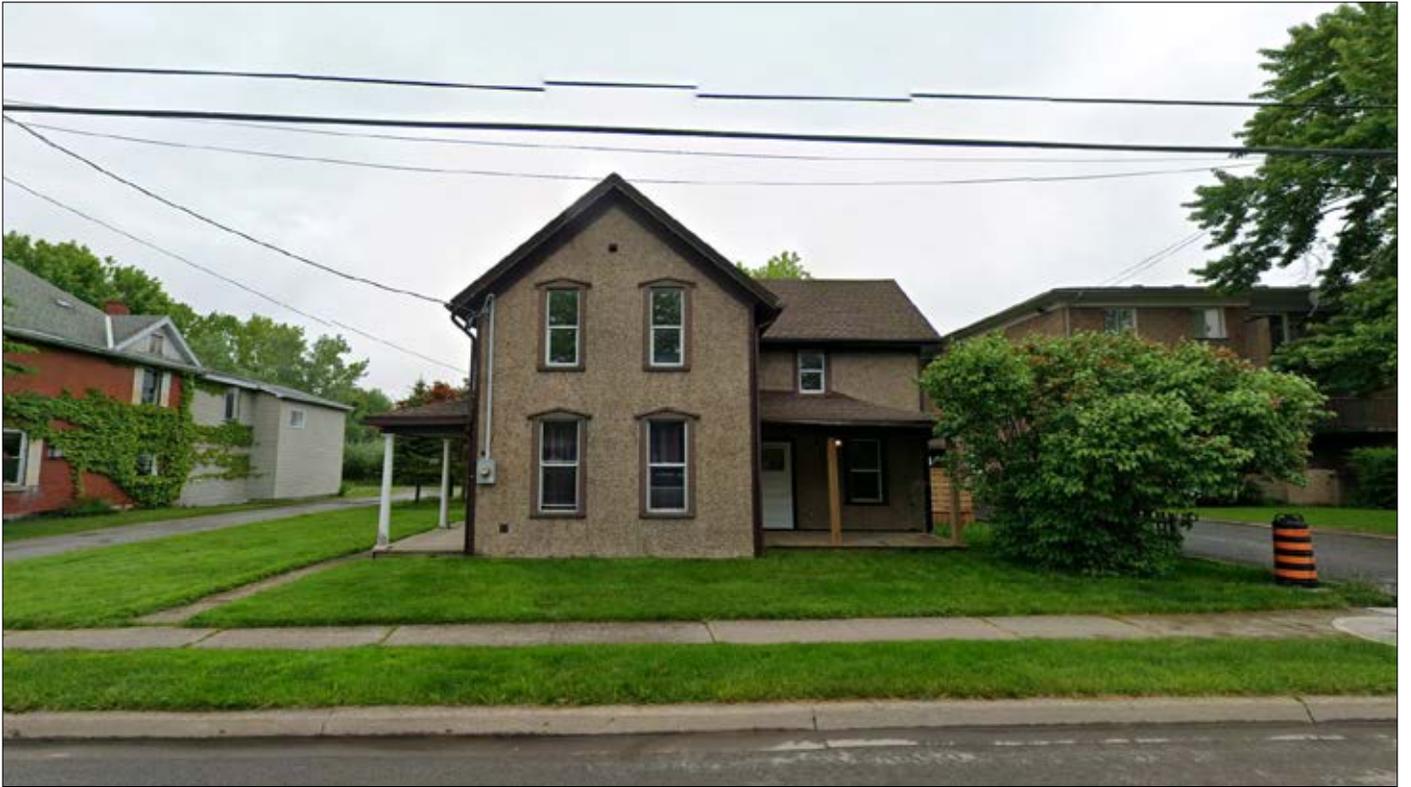
Figure 44. **Photo of 537 King Street (Front Elevation)**

The neighbouring property located to the immediate south of the Subject Site is municipally addressed as 537 King Street. The following review of existing conditions of the property is based on the elements that are visible from street view and information gleaned through aerial images. Based on aerial imaging, the property contains a single-detached residential dwelling, as well as two outbuildings. The dwelling appears to have an L-shaped floorplan with a rear addition.
