Phase Two Environmental Site Assessment
547 King Street, Port Colborne, ON

Date: December 9, 2025
NSSL File No.: NS25101-02

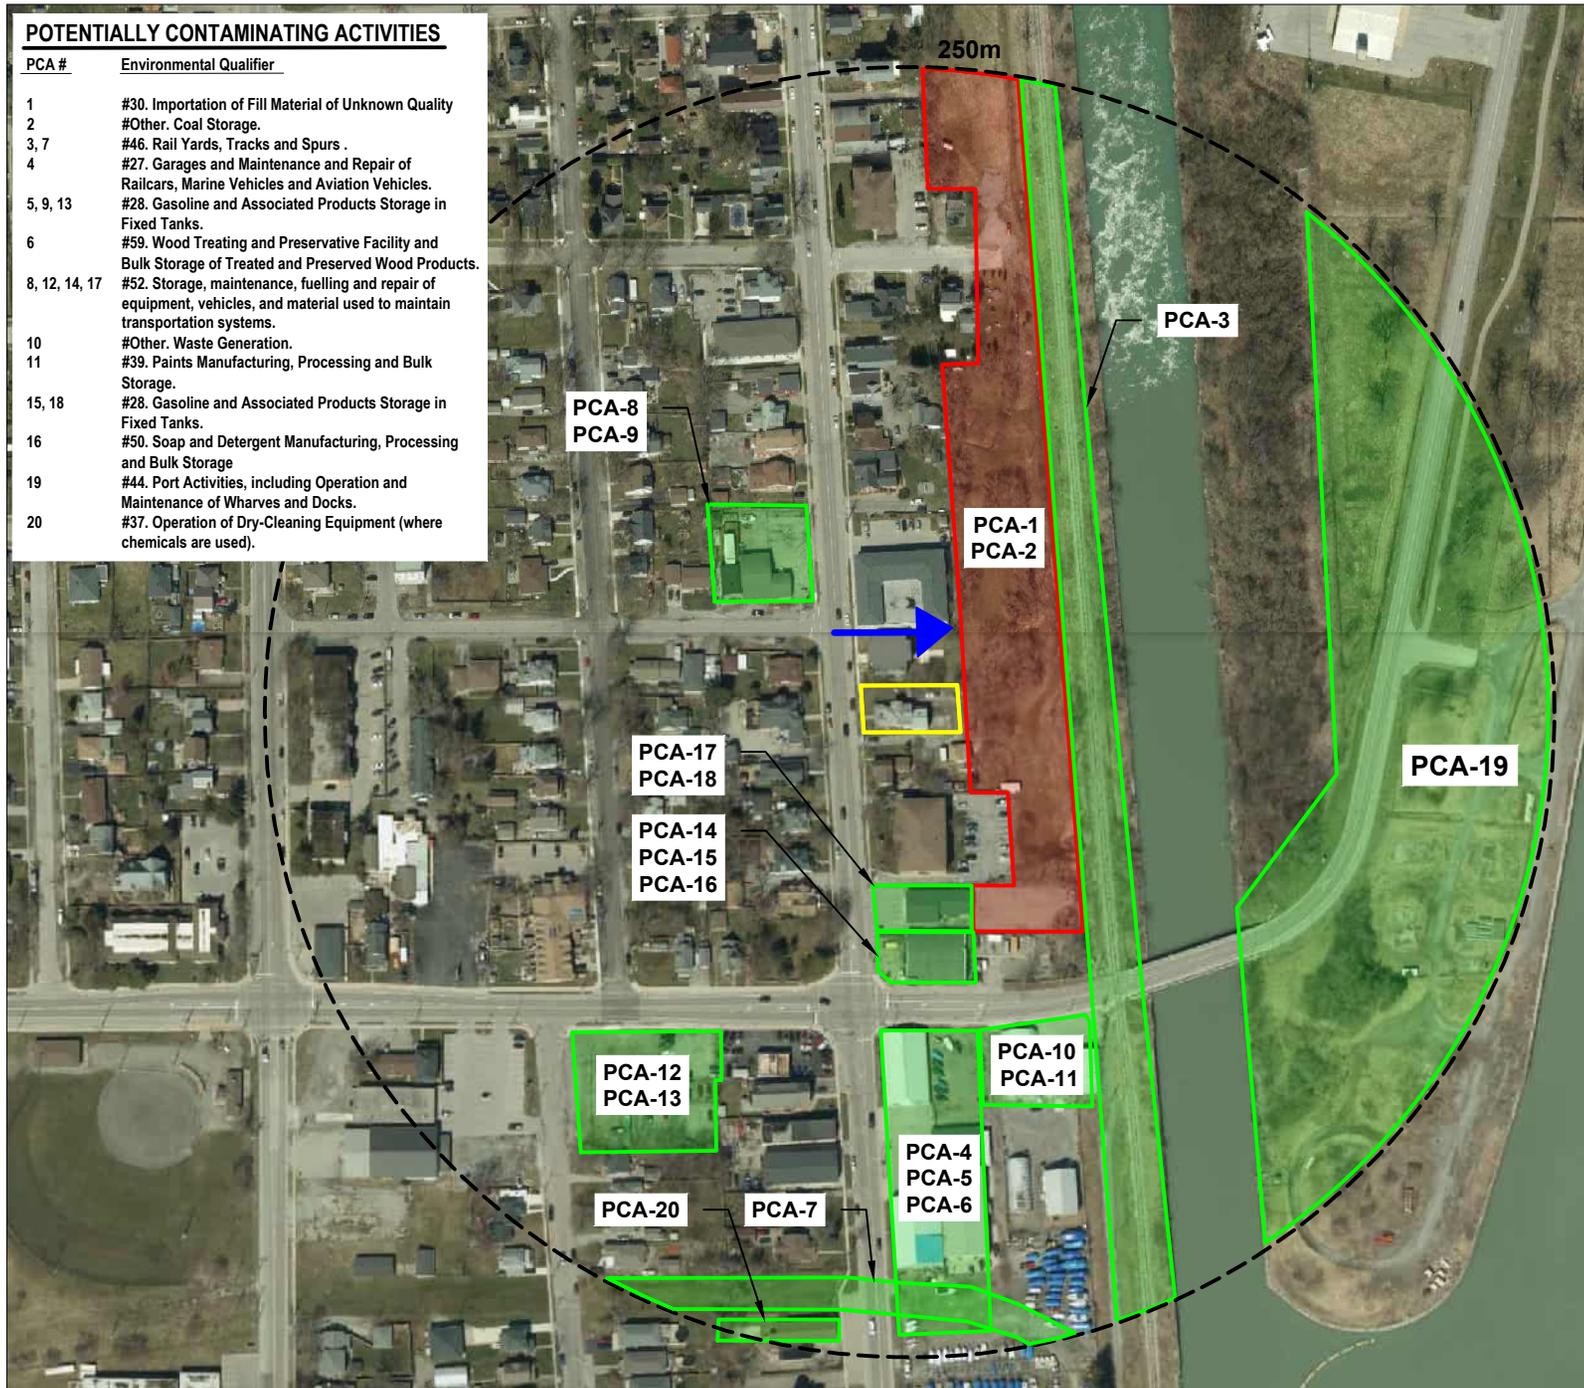
AREAS OF POTENTIAL ENVIRONMENTAL CONCERN

APEC #	Environmental Qualifier
1	#30. Importation of Fill Material of Unknown Quality
2	#Other. Coal Storage

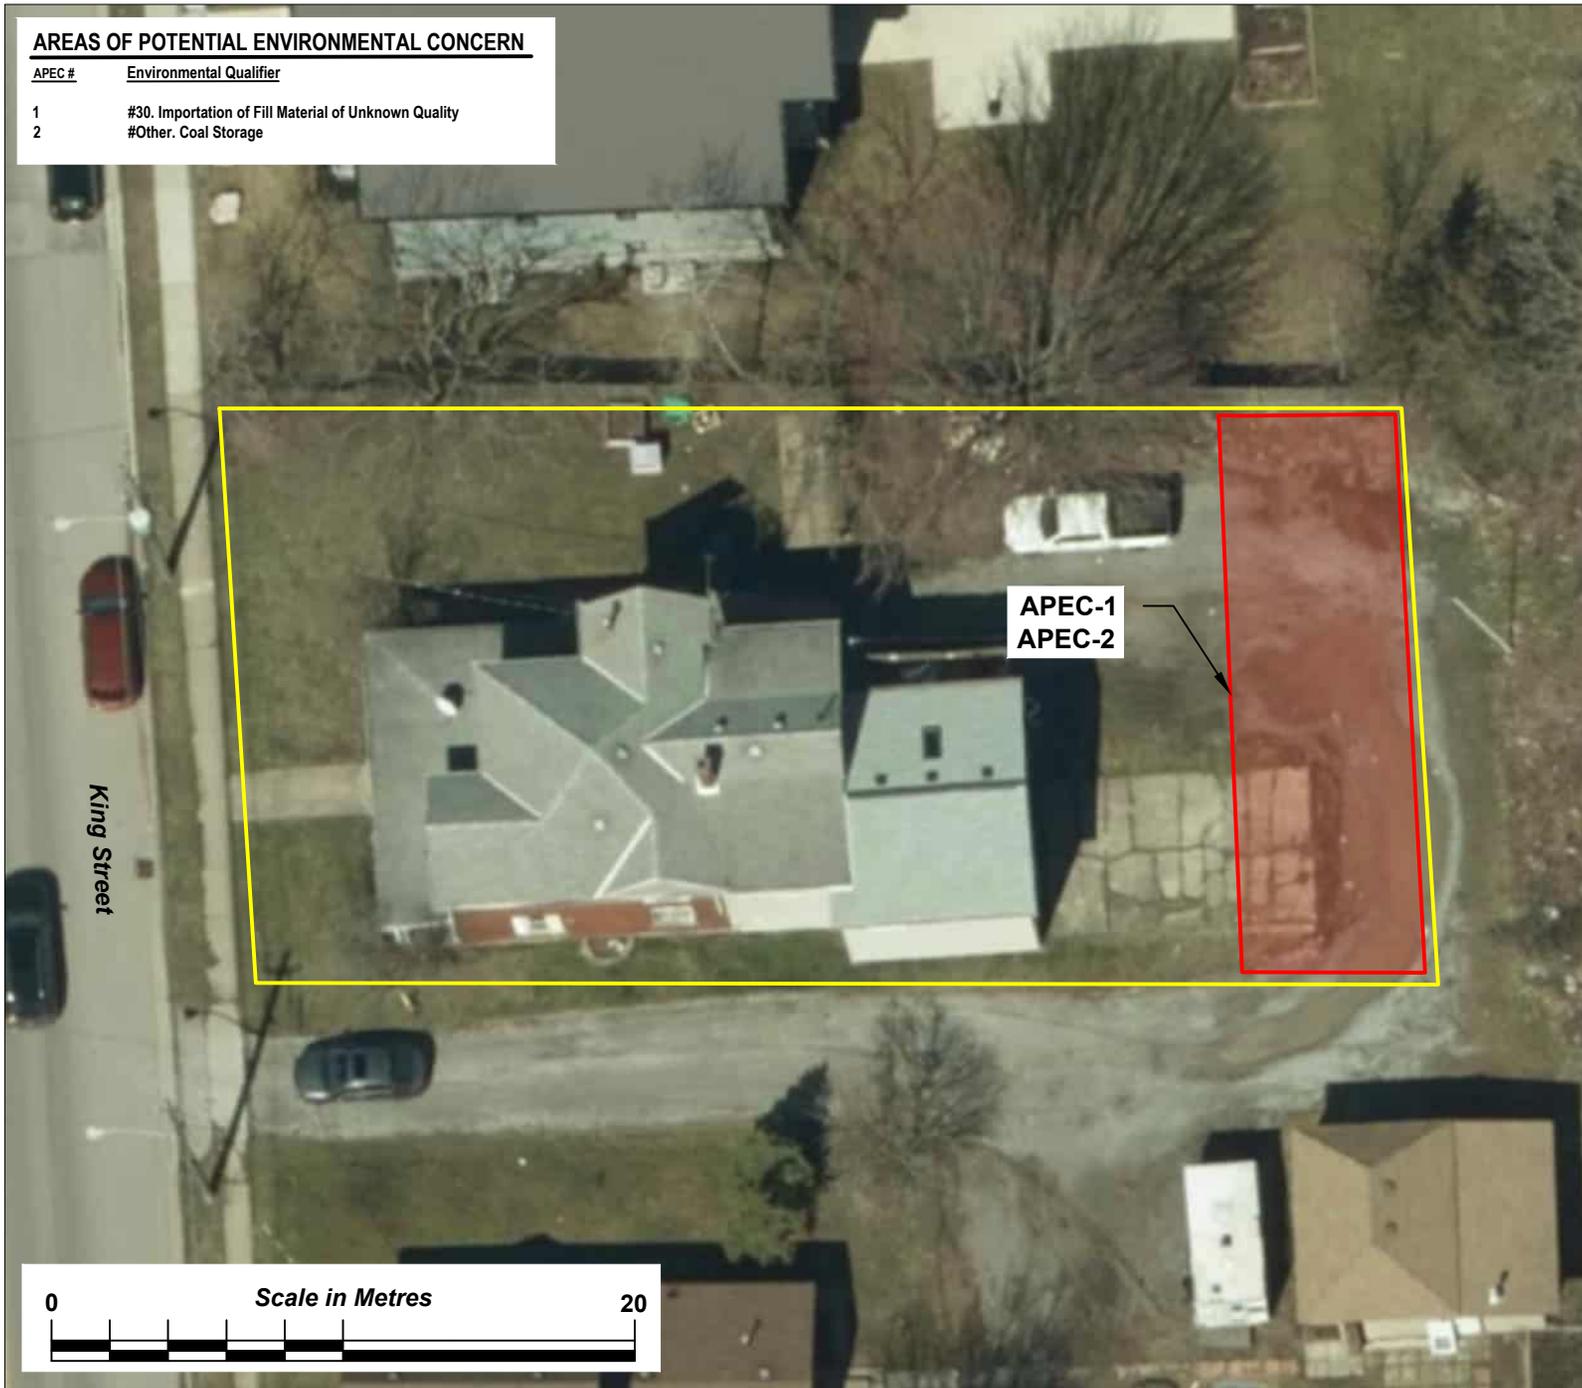
NO:
Figure 4

- Property Boundary
- APEC

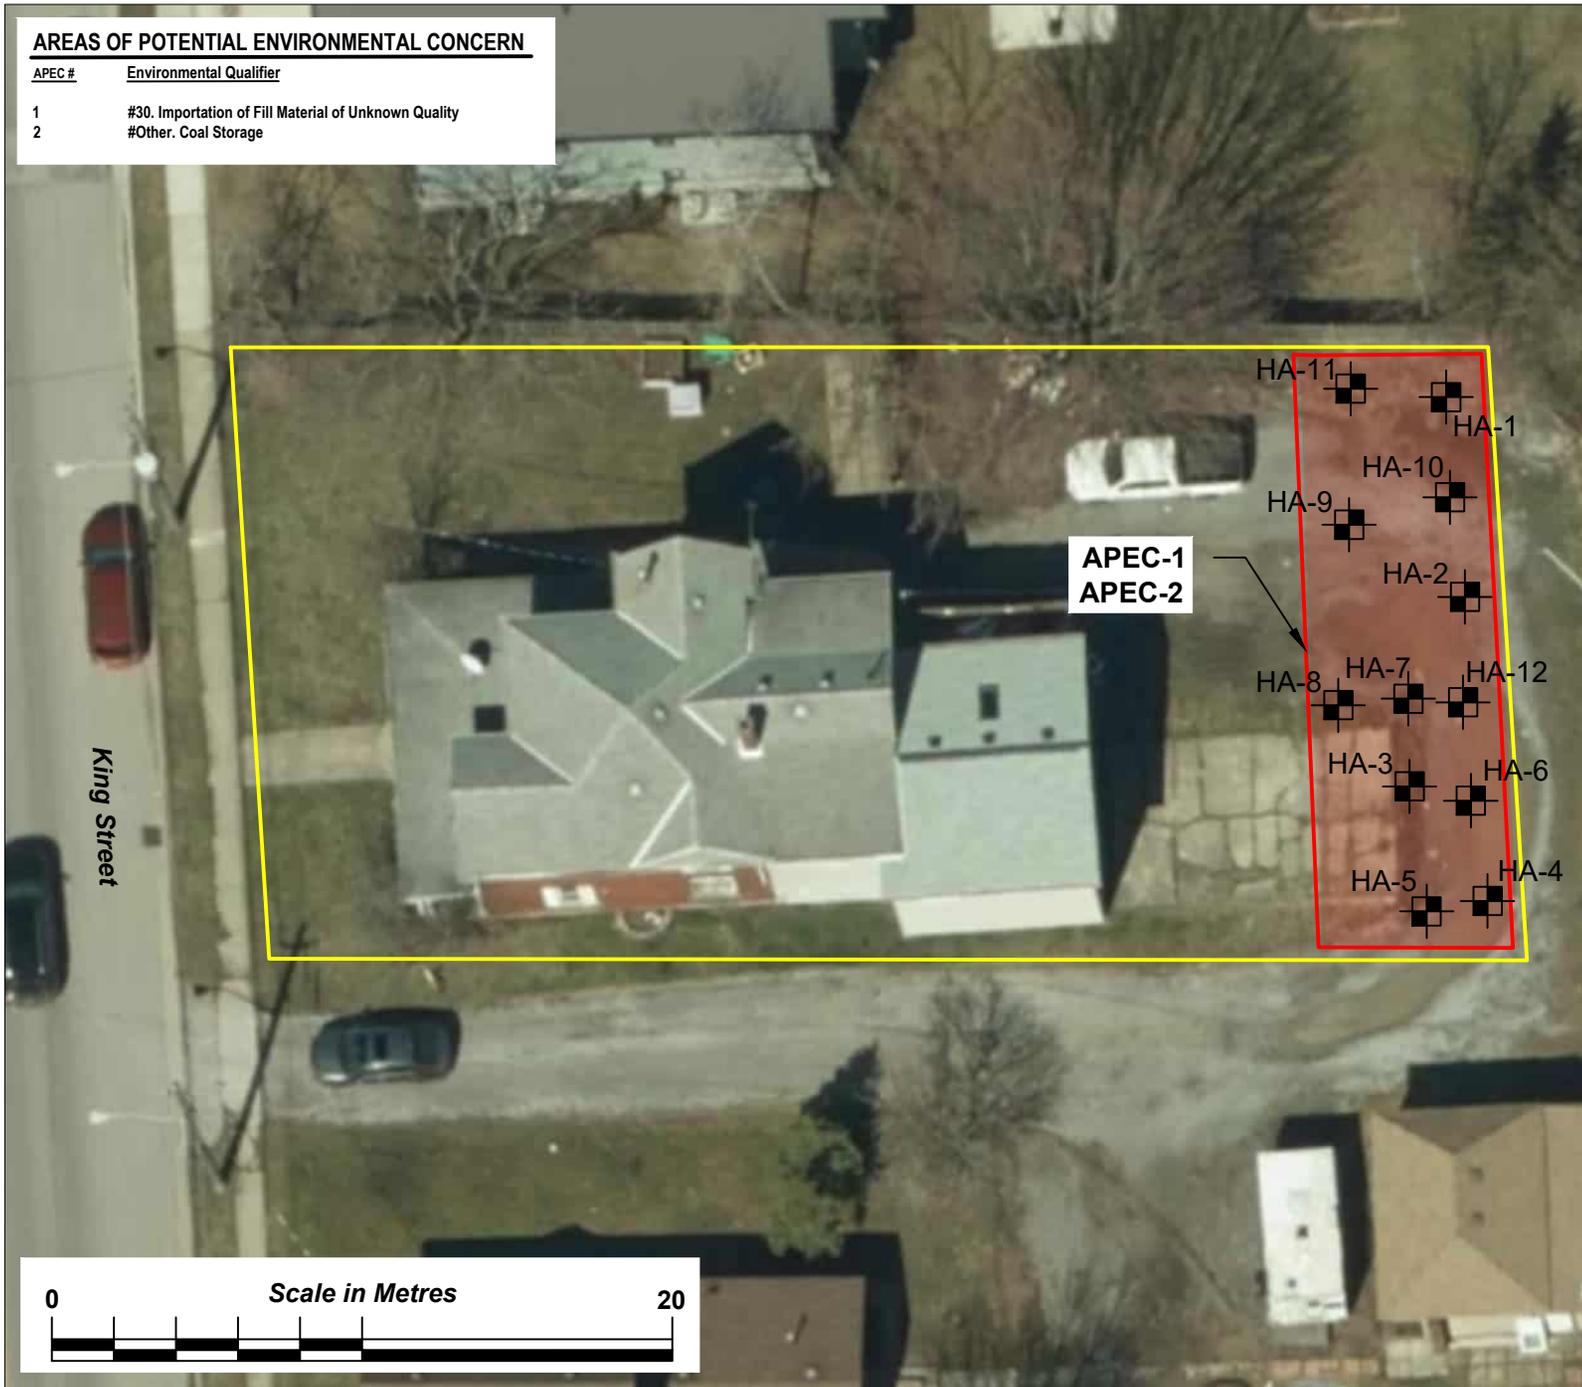
NO:
Figure 5

- Property Boundary
- APEC
- +
 Hand Auger Location

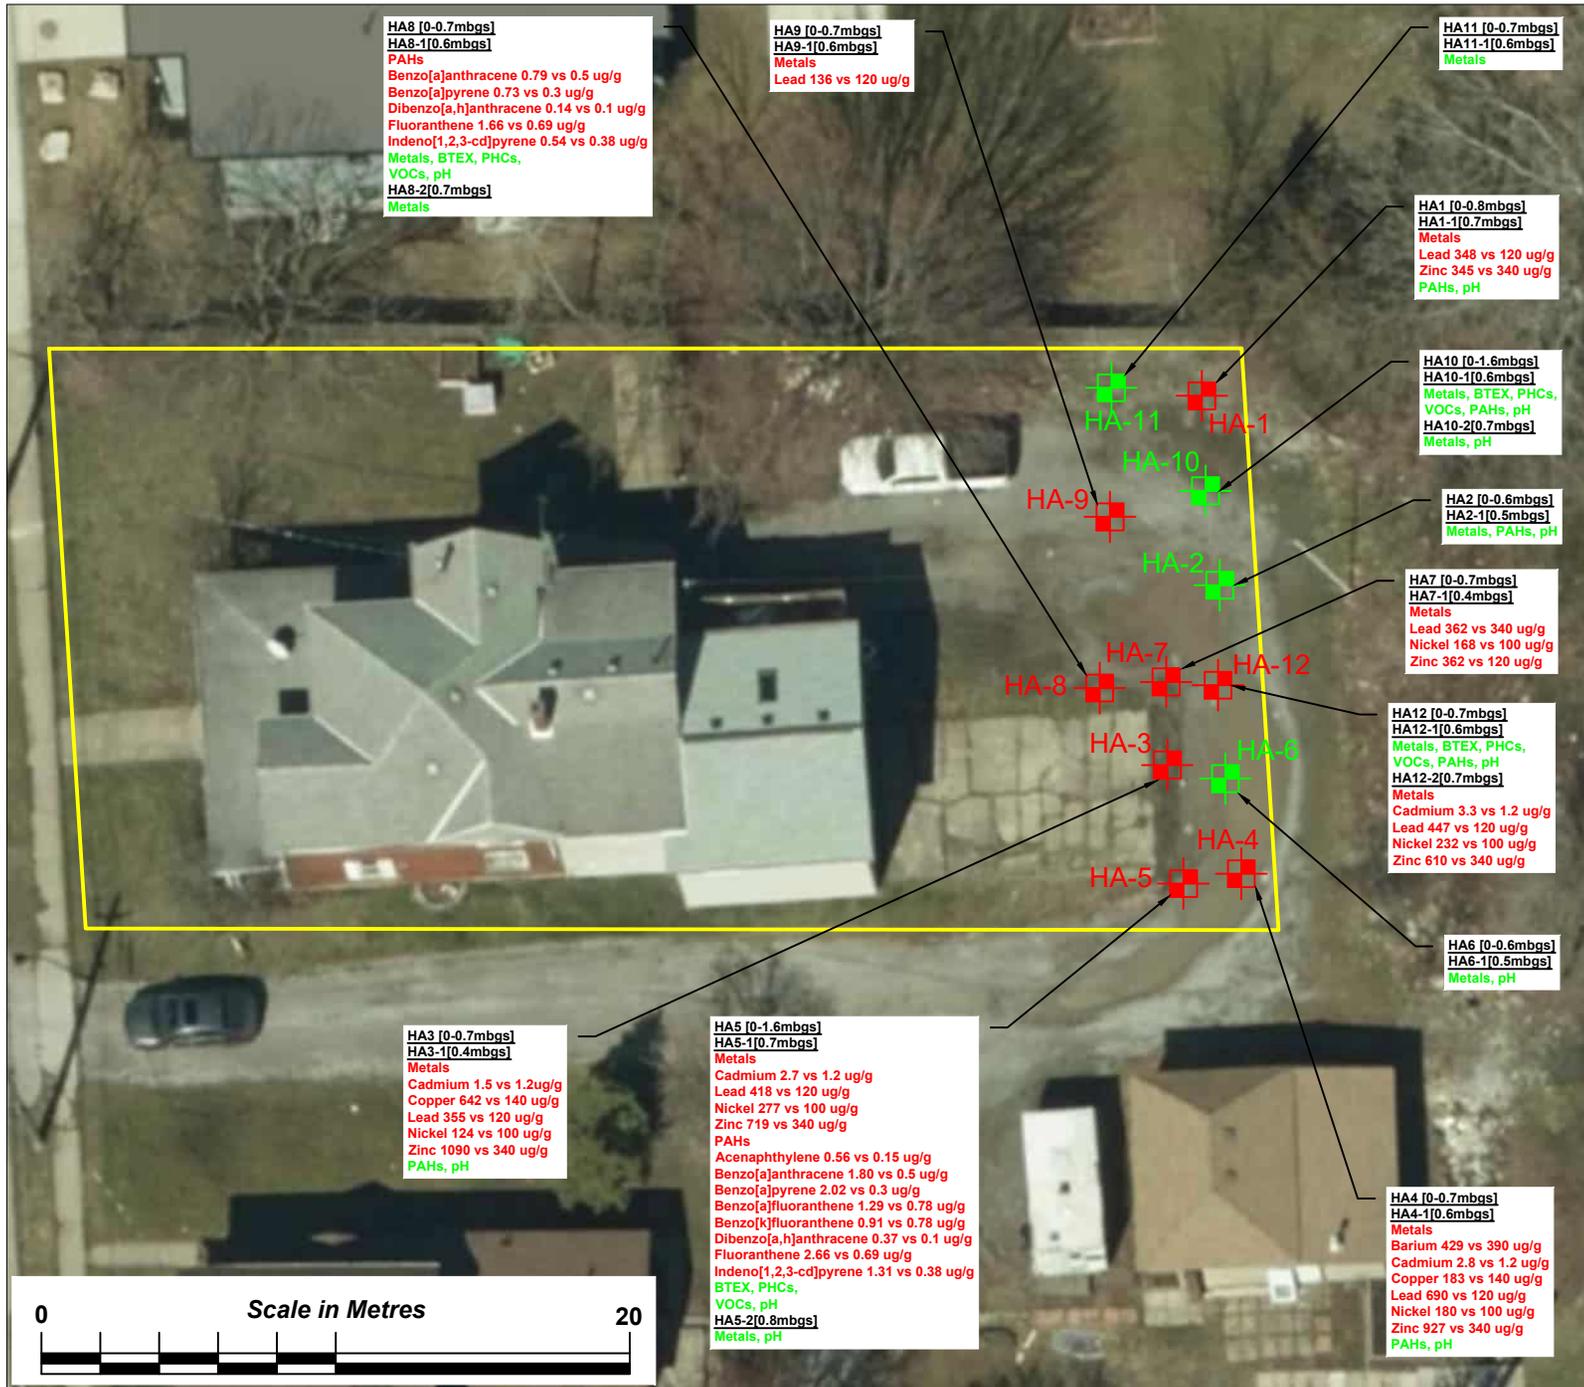
NO:
 Figure 6

HA8 [0-0.7mbgs]
HA8-1[0.6mbgs]
PAHs
 Benzo[a]anthracene 0.79 vs 0.5 ug/g
 Benzo[a]pyrene 0.73 vs 0.3 ug/g
 Dibenzo[a,h]anthracene 0.14 vs 0.1 ug/g
 Fluoranthene 1.66 vs 0.69 ug/g
 Indeno[1,2,3-cd]pyrene 0.54 vs 0.38 ug/g
Metals, BTEX, PHCs,
VOCs, pH
HA8-2[0.7mbgs]
Metals

HA9 [0-0.7mbgs]
HA9-1[0.6mbgs]
Metals
 Lead 136 vs 120 ug/g

Soil sampling was conducted on September 12th and October 16th, 2025. A total of 24 representative soil samples were obtained from the fill, reworked, and native materials. Sixteen soil samples were submitted to AGAT and Paracel for analysis of Metals, As, Sb, Se, PHCs, BTEX, PAHs, VOCs, and pH. The reported soil laboratory results did not meet Table 3 Non-Potable Groundwater Condition Standards for R/P/I land use for coarse-grained soil criteria. Based upon the initial HA results test pits were advanced throughout the site for confirmation of soil quality against Metals by ICP and PAHs with the addition of PHC/BTEX for the test pits located beneath the concrete pad. These reported results were also shown to exceed the applicable standard as tabulated below and displayed in Figures 6 and 7. The complete laboratory reports are provided in Appendix B.

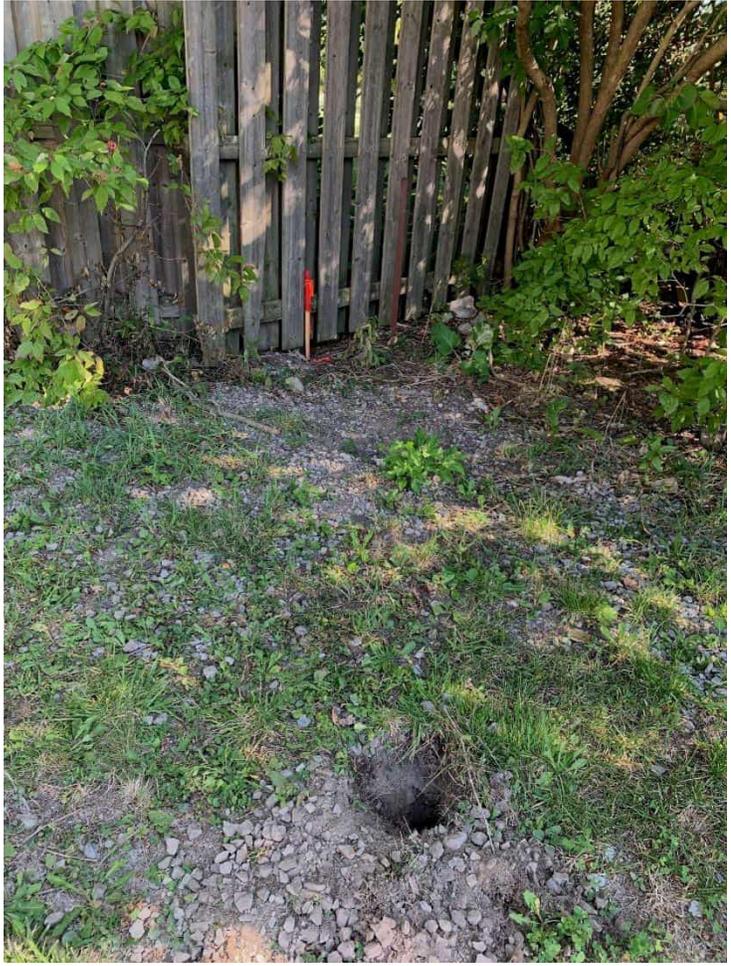
0.70 – 0.80	Native – Light brown silty clay, trace gravel and organics, firm, no staining or odours.	HA1-2	0.80	Grab	Native
<ol style="list-style-type: none"> 1. Auger Hole Oriented: North & South 2. Auger Hole Size (m): 0.75 x 0.75mm 3. Water Encountered: No 4. Auger Hole Caved: No 5. Machine/Tools: Shovel + Hand Auger 6. Eagle Gas Reading: 0 ppm 7. Additional Information: East side of property. 		Photo(s)

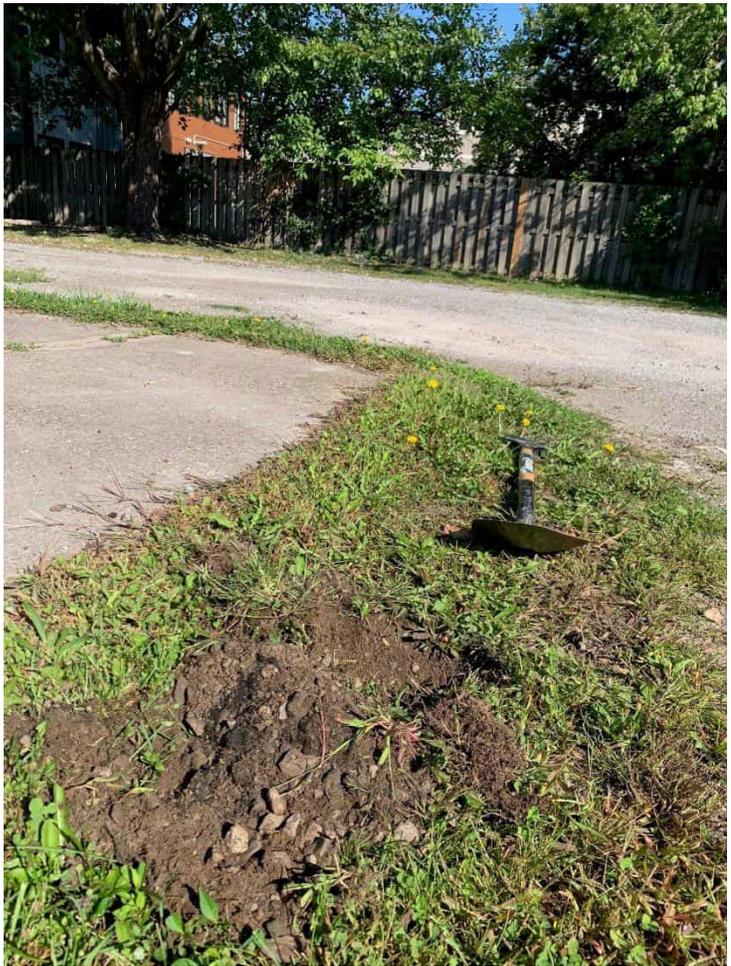
0.40 – 0.70	Native – Light brown silty clay, trace gravel and organics, firm, no staining or odours. Native started at 0.60m	HA3-2	0.60	Grab	Fill to Native

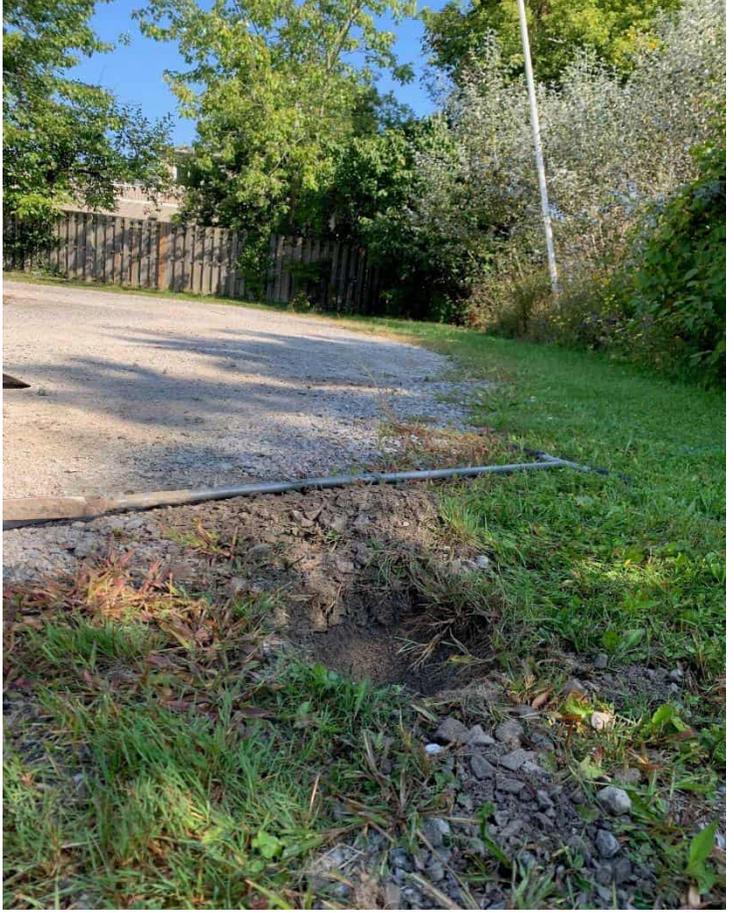
0.60 – 0.70	Native – Light brown silty clay, trace gravel and organics, firm, no staining or odours.	HA4-2	0.70	Grab	Native
1. Auger Hole Oriented: North & South		Photo(s)

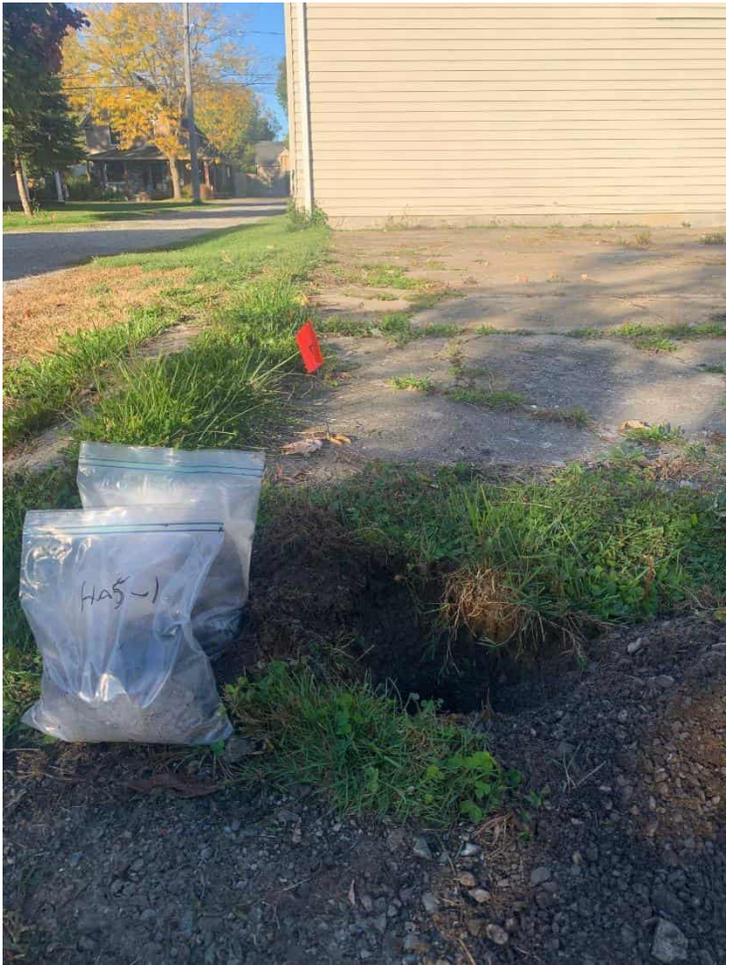
0.70 – 1.60	Native – Light brown silty clay, trace gravel and organics, firm, no staining or odours.	HA5-2	1.60	Grab	Native
1. Auger Hole Oriented: North & South 2. Auger Hole Size (m): 0.75 x 0.75mm 3. Water Encountered: No 4. Auger Hole Caved: No 5. Machine/Tools: Shovel + Hand Auger 6. Eagle Gas Reading: 0 ppm 7. Additional Information: Fill material observed.		Photo(s)

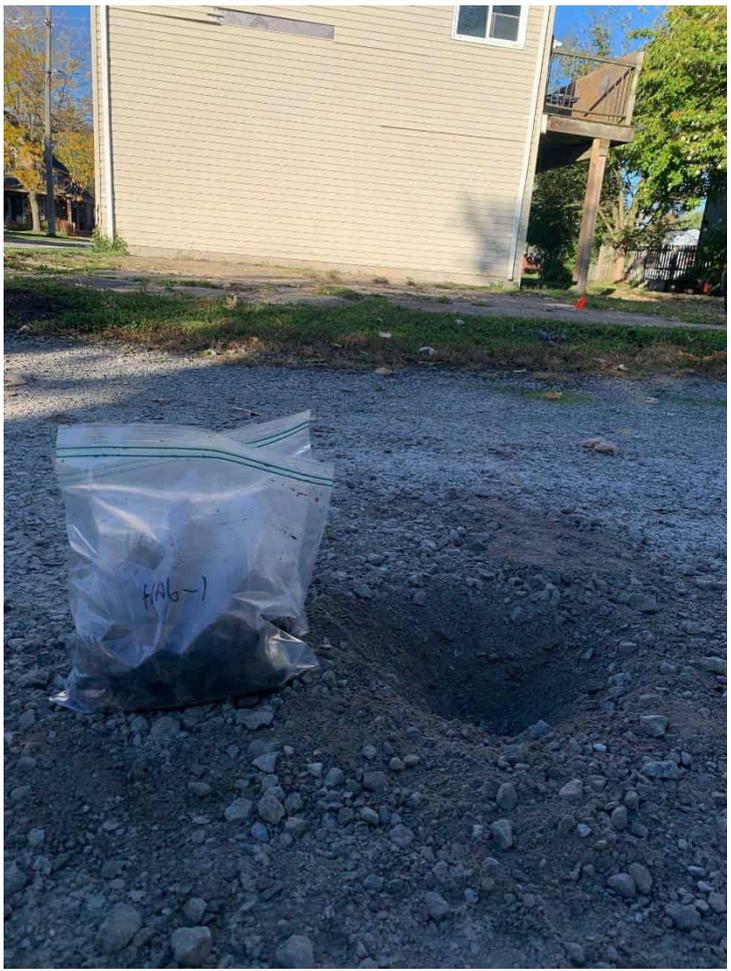
0.50 – 0.60	Native – Light brown silty clay, trace gravel and organics, firm, no staining or odours.	HA6-2	0.60	Grab	Native
1. Auger Hole Oriented: North & South		Photo(s)

7. Additional Information: Fill material observed.

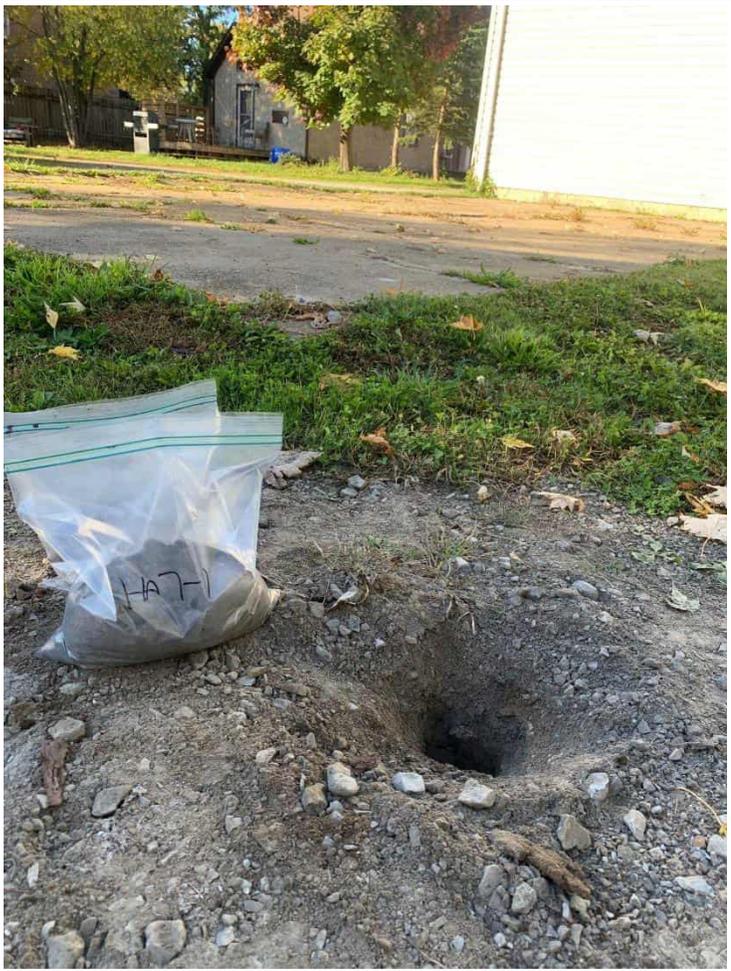
0.40 – 0.70	Native – Light brown silty clay, trace gravel and organics, firm, no staining or odours. Native started at 0.60m	HA7-2	0.70	Grab	Fill to Native

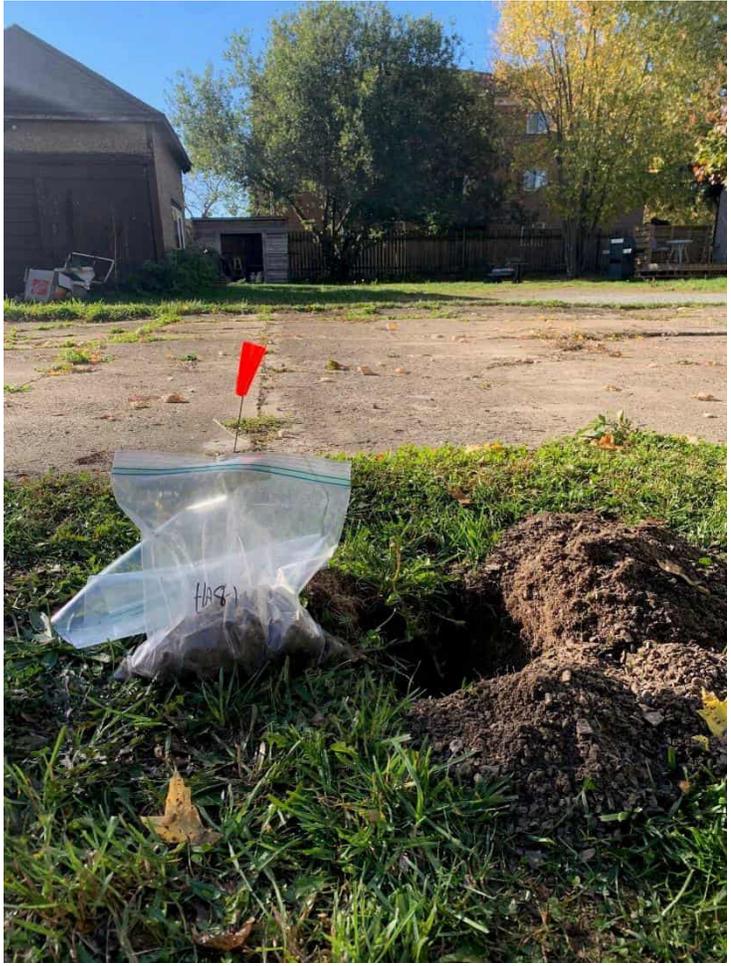
0.60 – 0.70	Native – Light brown silty clay, trace gravel and organics, firm, no staining or odours.	HA8-2	0.70	Grab	Native
1. Auger Hole Oriented: North & South		Photo(s)

7. Additional Information: Fill material observed.

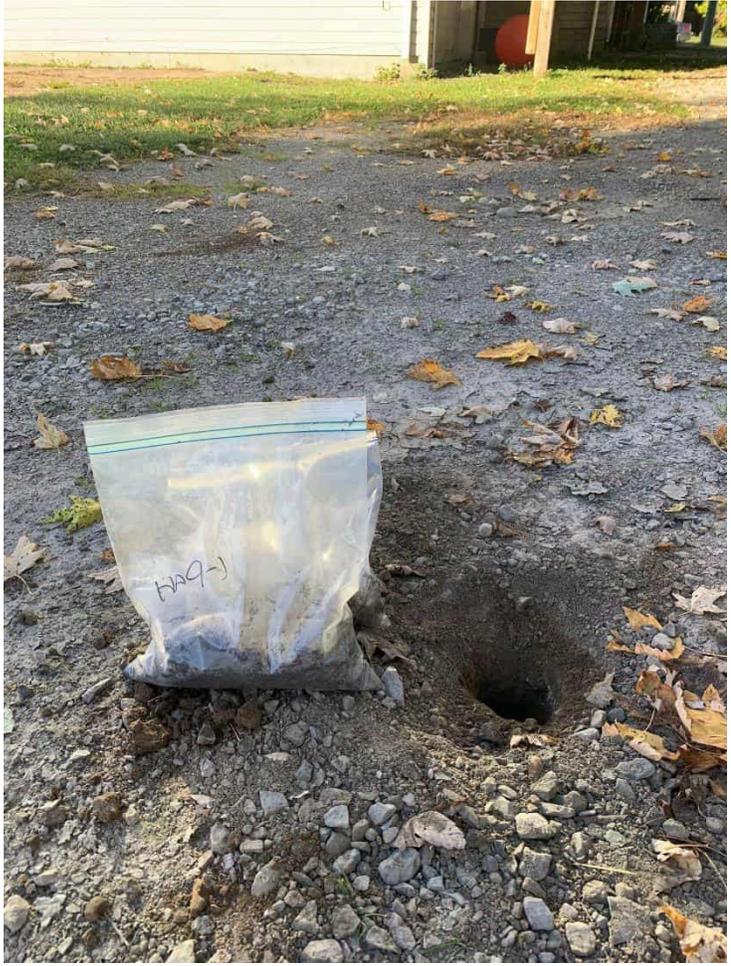
0.60 – 0.70	Native – Light brown silty clay, trace gravel and organics, firm, no staining or odours.	HA9-2	0.70	Grab	Native
<ol style="list-style-type: none"> 1. Auger Hole Oriented: North & South 2. Auger Hole Size (m): 0.75 x 0.75mm 3. Water Encountered: No 4. Auger Hole Caved: No 5. Machine/Tools: Shovel + Hand Auger 6. Eagle Gas Reading: 0 ppm 7. Additional Information: Fill material observed. 		Photo(s)

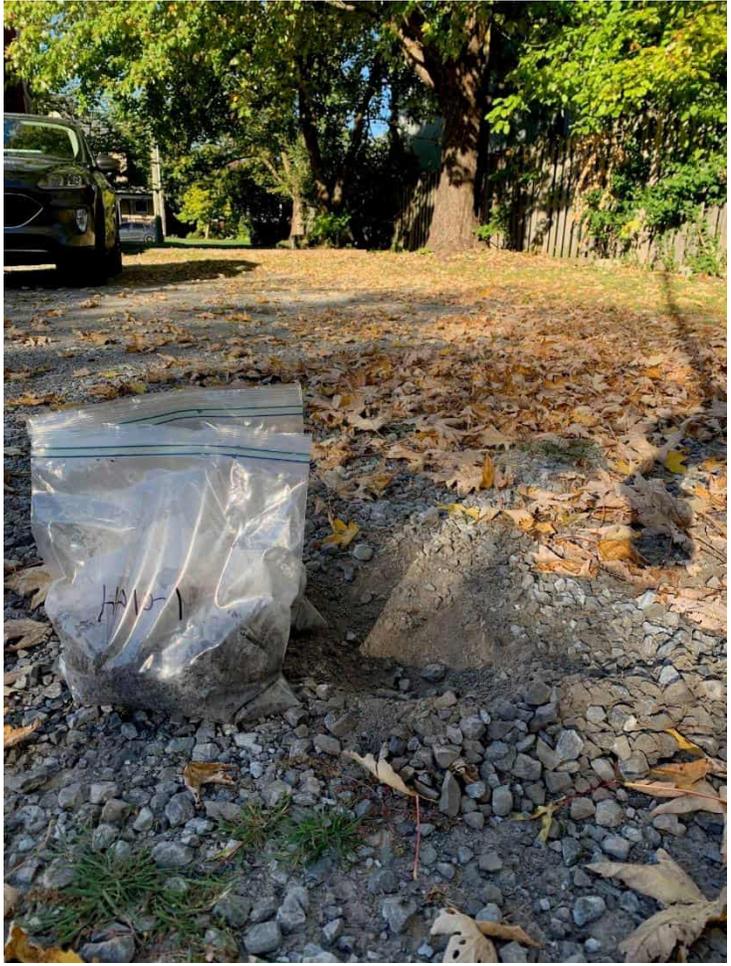
0.60 – 1.60	Native – Light brown silty clay, trace gravel and organics, firm, no staining or odours.	HA10-2	1.60	Grab	Native
1. Auger Hole Oriented: North & South		Photo(s)

7. Additional Information: Fill material observed.

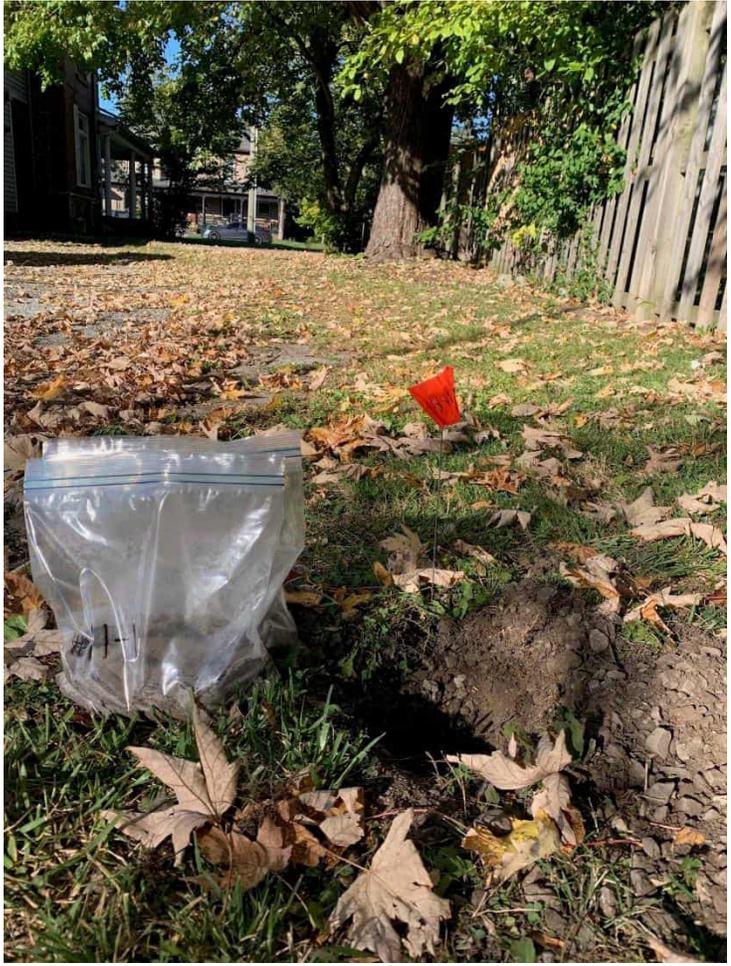
0.60 – 0.70	Native – Light brown silty clay, trace gravel and organics, firm, no staining or odours.	HA11-2	0.70	Grab	Native
1. Auger Hole Oriented: North & South		Photo(s)

7. Additional Information: Fill material observed.

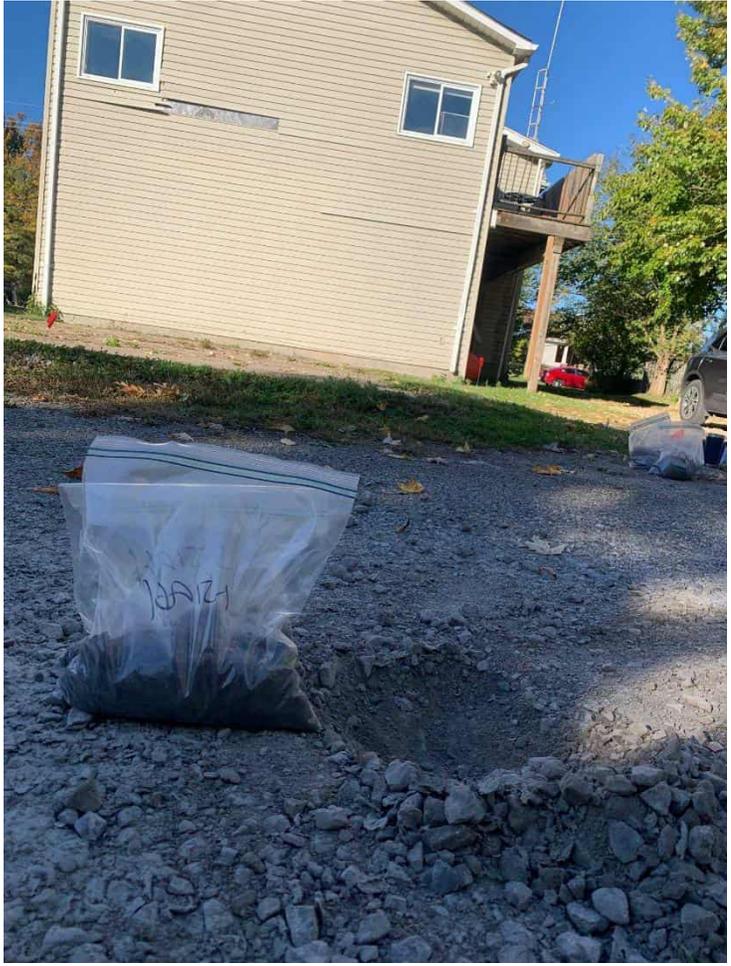
0.60 – 0.70	Native – Light brown silty clay, trace gravel and organics, firm, no staining or odours.	HA12-2	0.70	Grab	Native
1. Auger Hole Oriented: North & South		Photo(s)

7. Additional Information: Fill material observed.

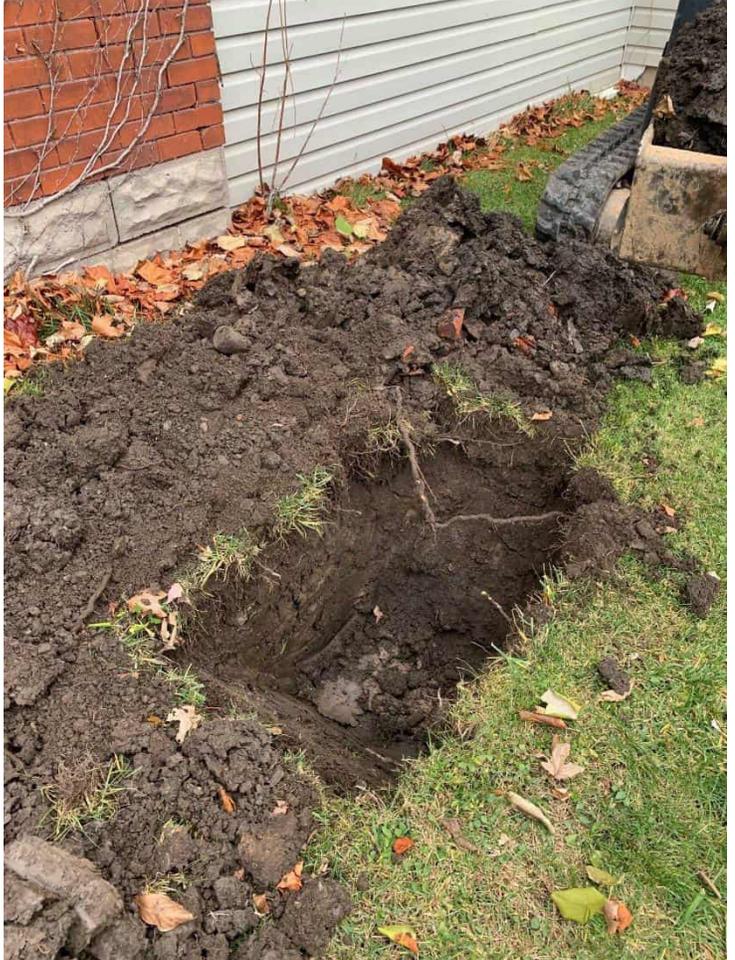
1. Test Pit Oriented: North & South 2. Test Pit Size (m): 0.50 x 0.90m 3. Water Encountered: No 4. Test Pit Caved: No 5. Machine/Tools: Jays Mini Excavator 6. Eagle Gas Reading: 0 ppm 7. Additional Information: Along the southern property boundary.		Photo(s)

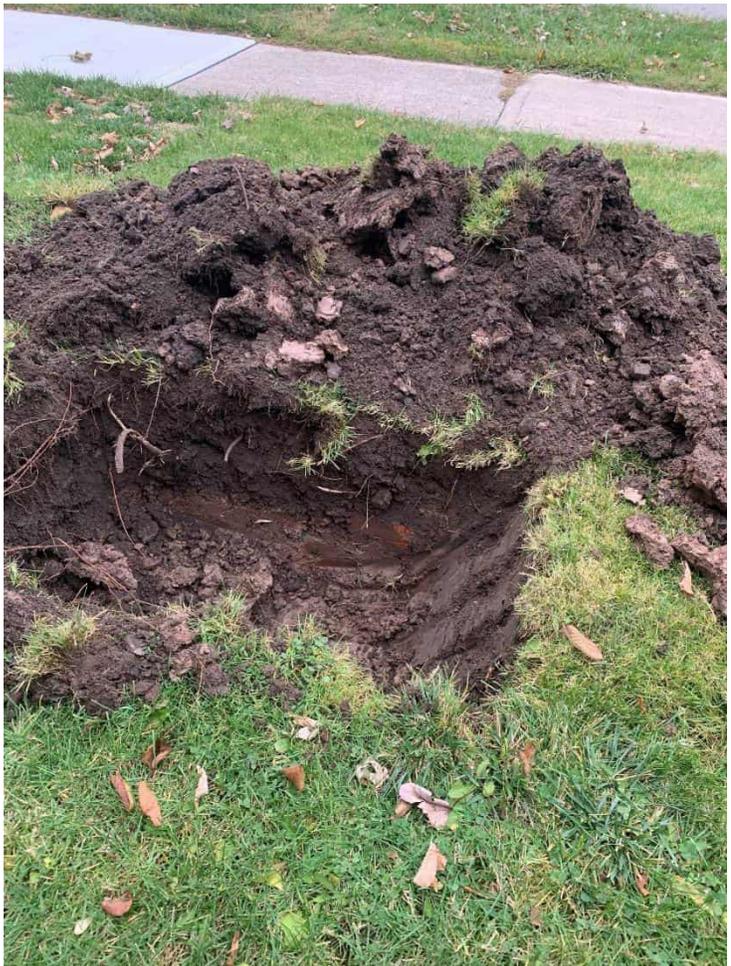
6. Eagle Gas Reading: 0 ppm					
7. Additional Information: Along the south western property boundary.

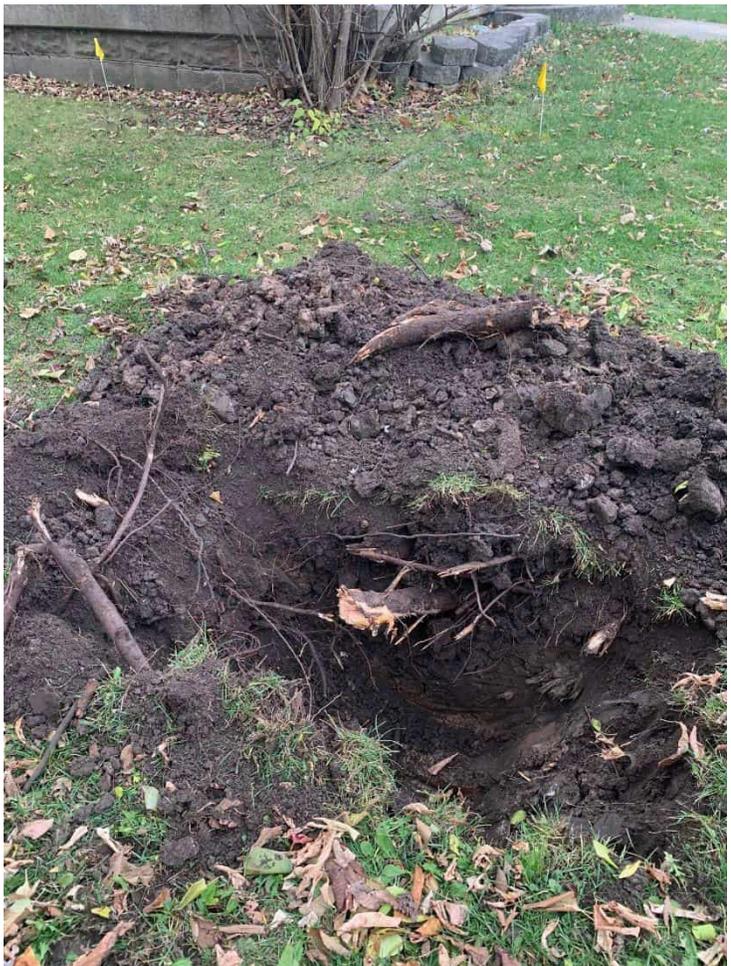
6. Eagle Gas Reading: 0 ppm					
7. Additional Information: Along the north western property boundary.

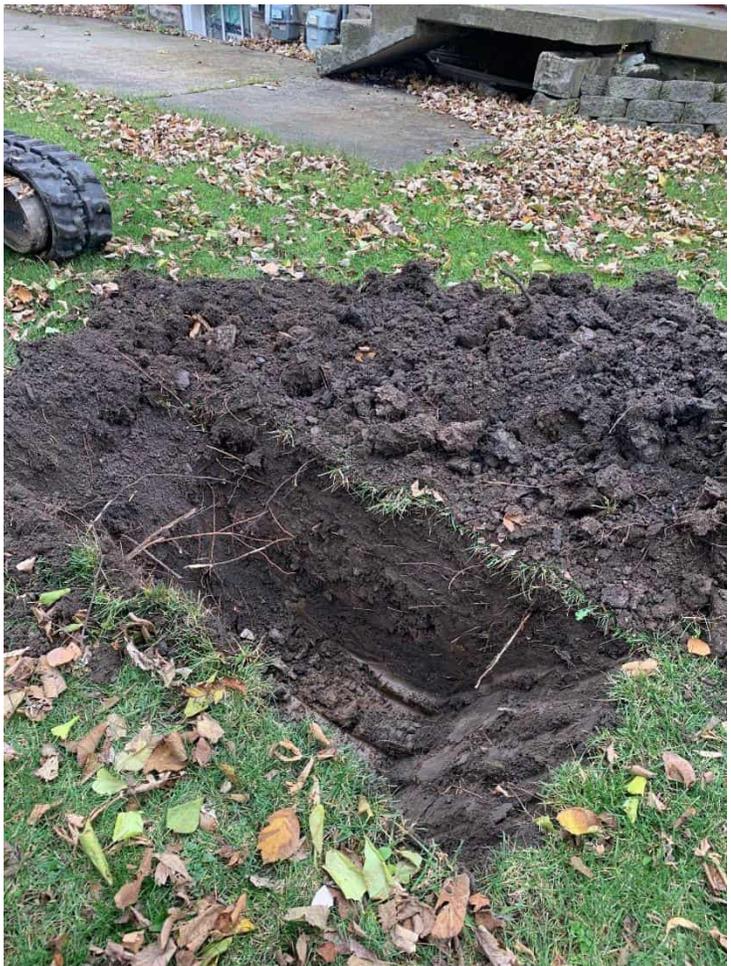
1. Test Pit Oriented: North & South 2. Test Pit Size (m): 0.50 x 0.90m 3. Water Encountered: No 4. Test Pit Caved: No 5. Machine/Tools: Jays Mini Excavator 6. Eagle Gas Reading: 0 ppm 7. Additional Information: Along the northern part of the property.		Photo(s)

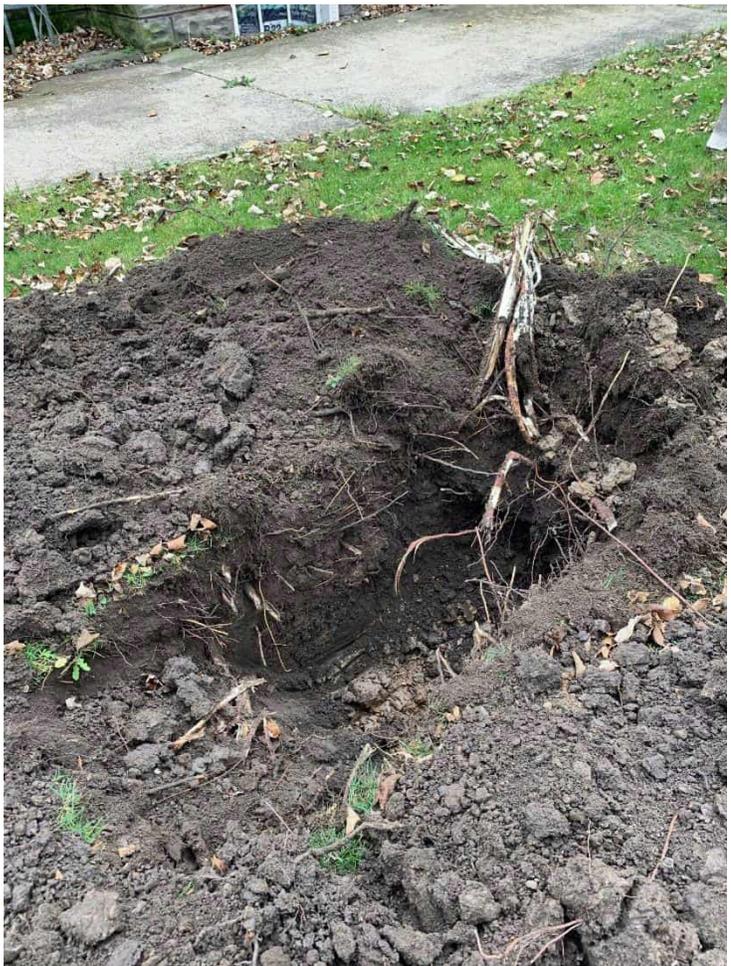
6. Eagle Gas Reading: 0 ppm					
7. Additional Information: Along the northern part of the property.

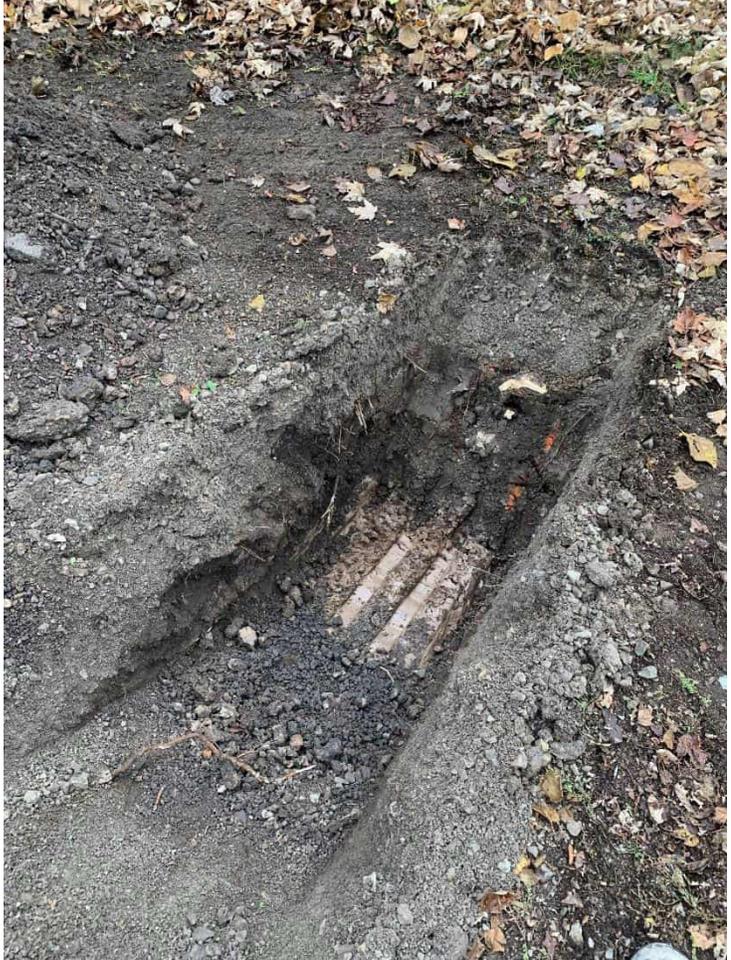
6. Eagle Gas Reading: 0 ppm					
7. Additional Information: Along the northern part of the property.

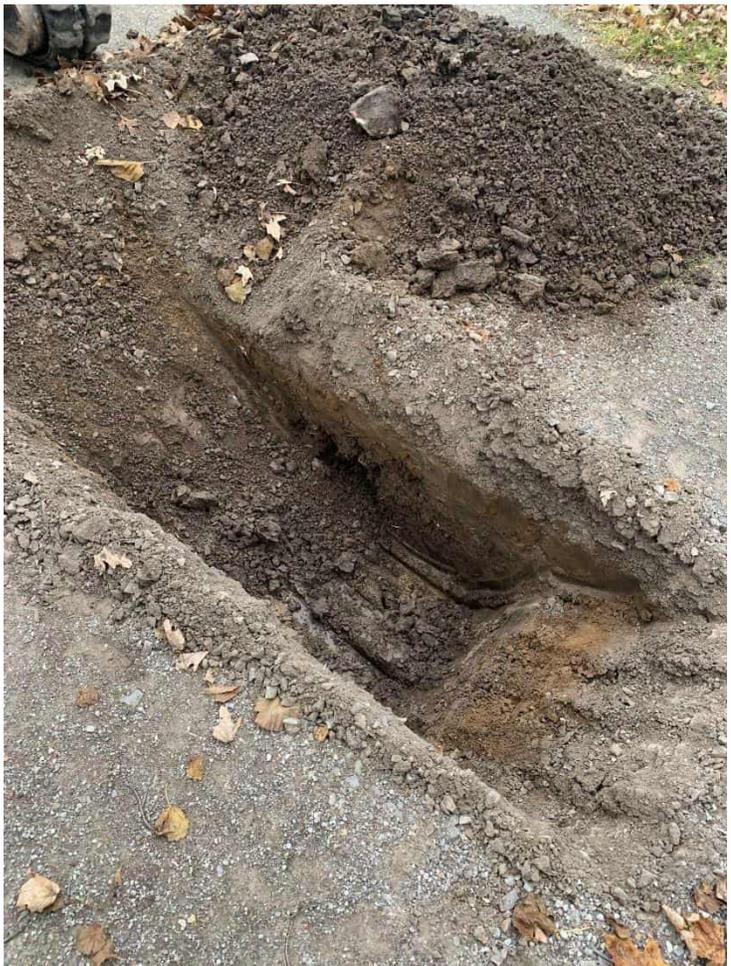
6. Eagle Gas Reading: 0 ppm					
7. Additional Information: Along the northern part of the property.
