Phase Two Environmental Site Assessment
547 King Street, Port Colborne, ON

Date: December 9, 2025
NSSL File No.: NS25101-02

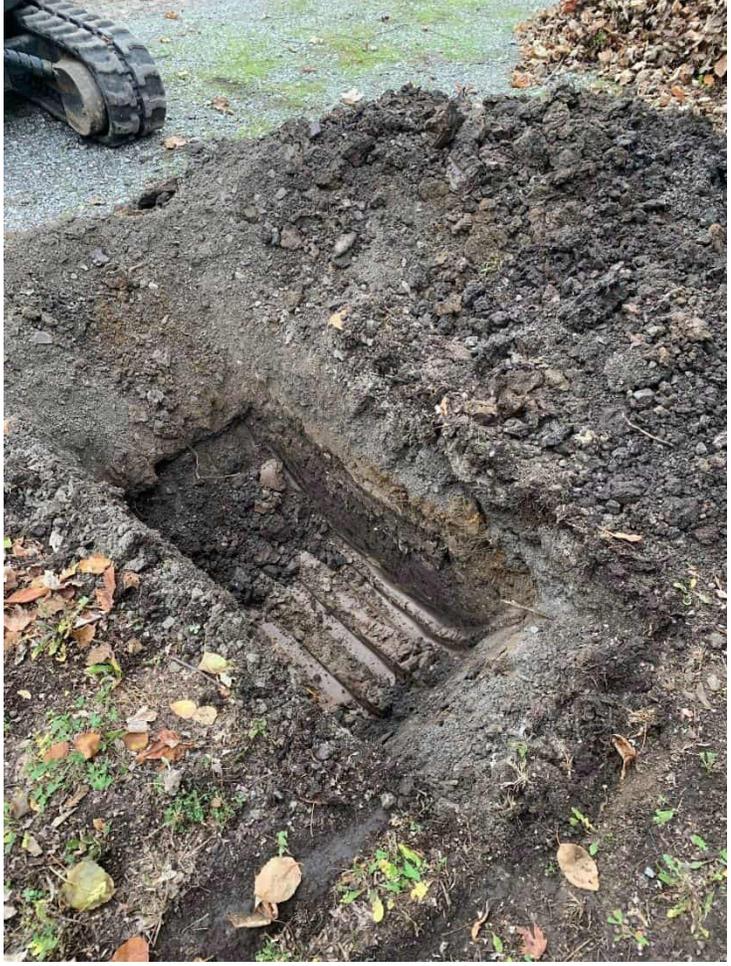
6. Eagle Gas Reading: 0 ppm					
7. Additional Information: Along the northern part of the property.

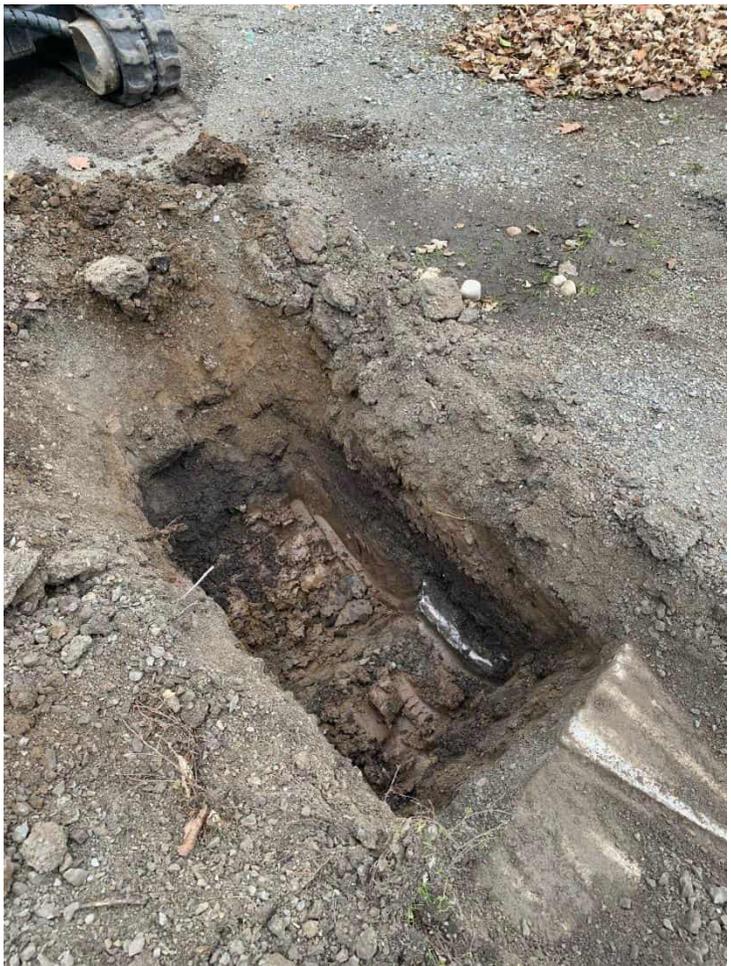
6. Eagle Gas Reading: 0 ppm					
7. Additional Information: Along the northern part of the property and concrete pad.

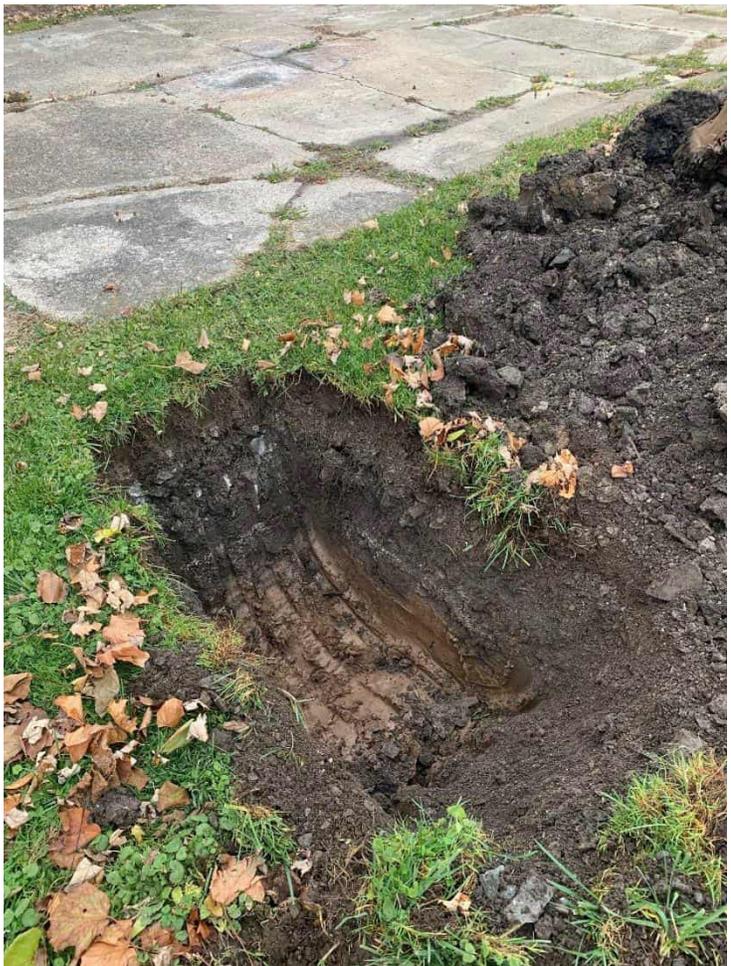
6. Eagle Gas Reading: 0 ppm					
7. Additional Information: Along the southern part of the property and south of the concrete pad.

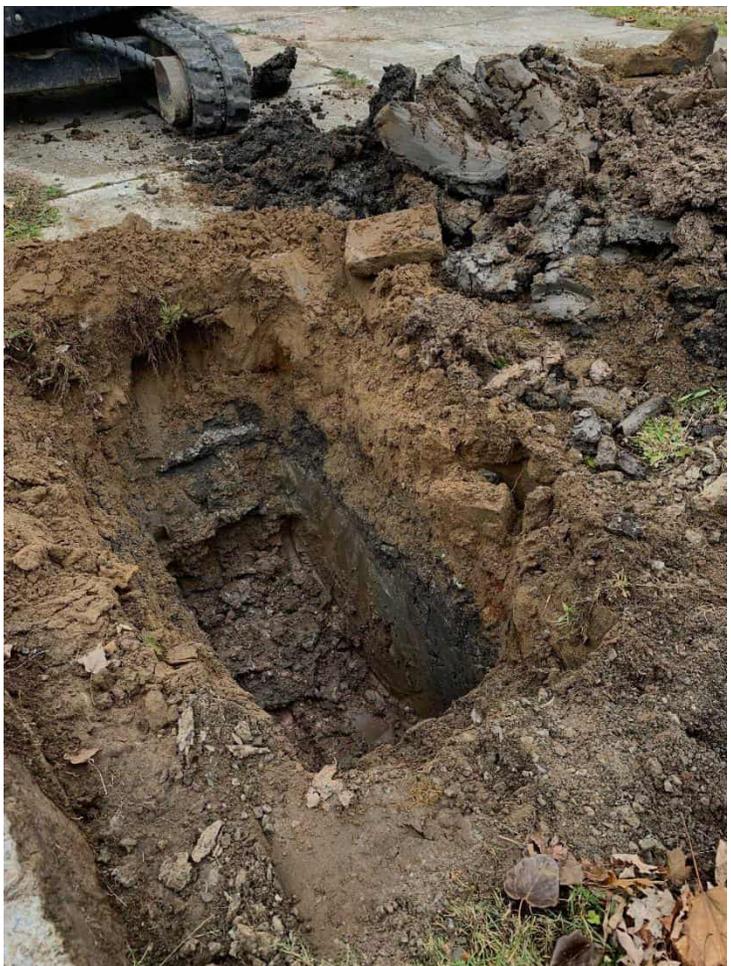
6. Eagle Gas Reading: 0 ppm					
7. Additional Information: Within the concrete slab area.

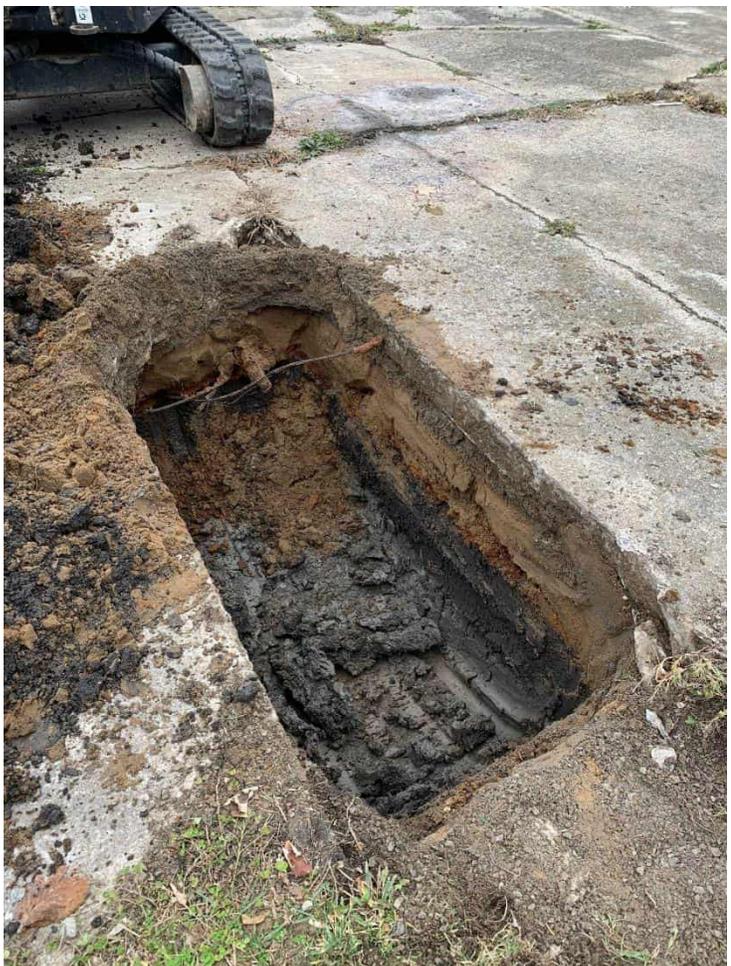
6. Eagle Gas Reading: 0 ppm					
7. Additional Information: Within the concrete slab area.

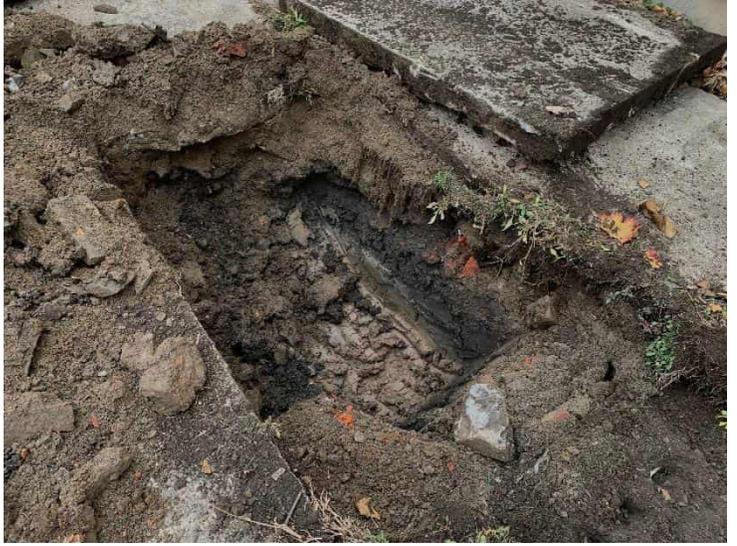
6. Eagle Gas Reading: 0 ppm					
7. Additional Information: Within the concrete slab area.
