650 Main Street West
Phase One Environmental Site Assessment

Project Location:
650 Main Street West
Port Colborne, ON
L3K 5V4

Date: March 3rd, 2022
NSSL File No.: NS2208-01

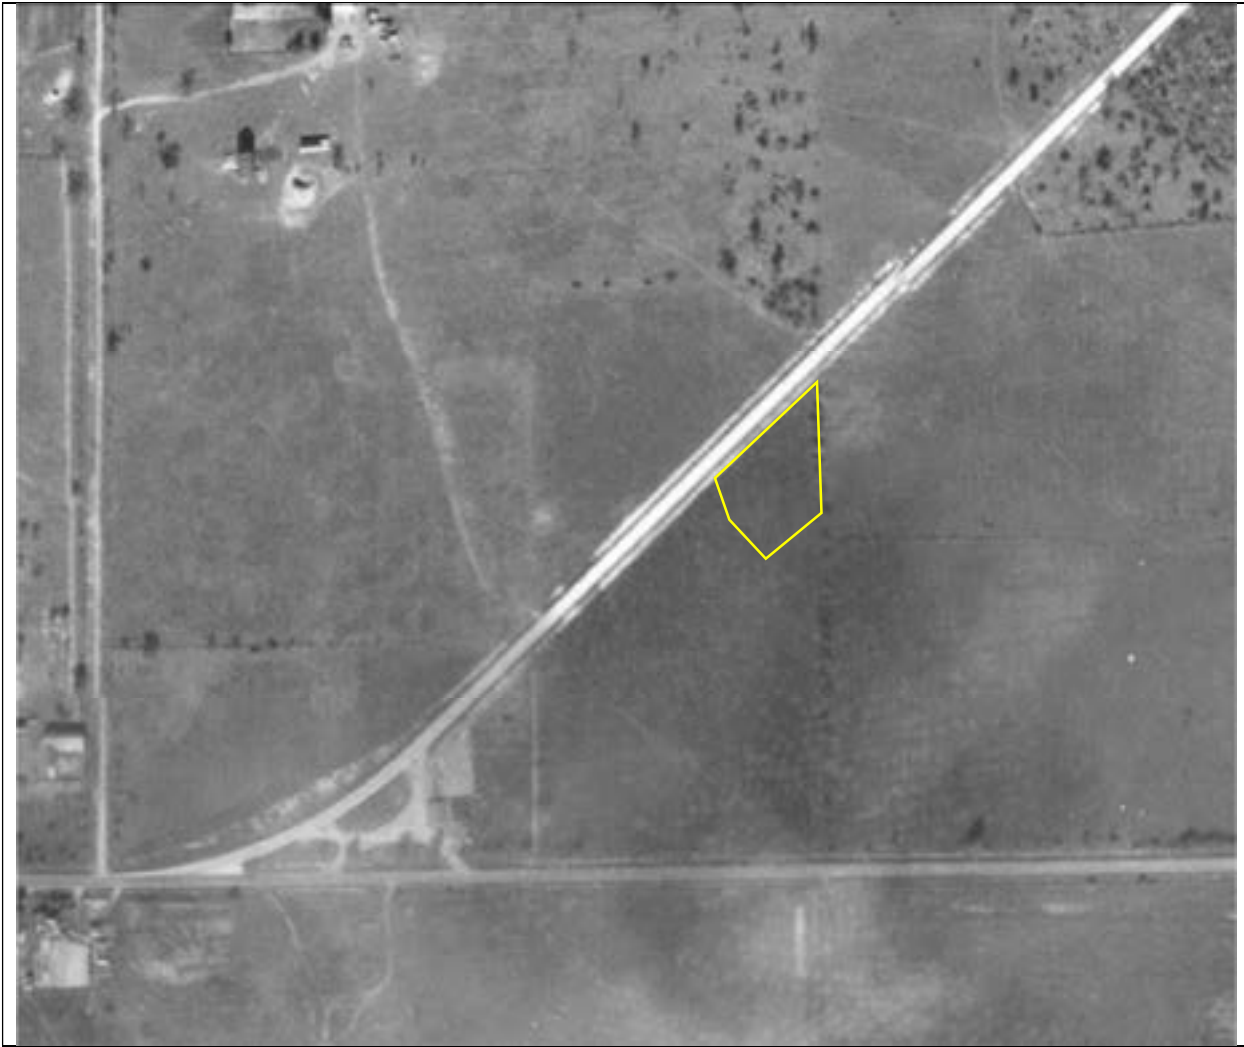
Date	Study Site	Study Area
1934	The aerial photograph depicts the study site as vacant/agricultural land with no structures onsite.	The adjacent properties are noted to be vacant/agricultural land. Main Street West is noted north of the site. The majority of the study area appears to be entirely undeveloped.
1954-55	The study site appears to be reworked and tilled, inferred to be associated with agricultural activities.	The north, west, and south adjacent properties appear to be agricultural. One [1] commercial property is noted southwest of the study area.
1965	The Seaway Motel has been developed onsite with one [1] elongated building on the property. Asphaltic concrete cover is utilized for parking due north of the building onsite.	The eastern portion of the study area has been developed into a residential subdivision.

Photograph No.1-1934

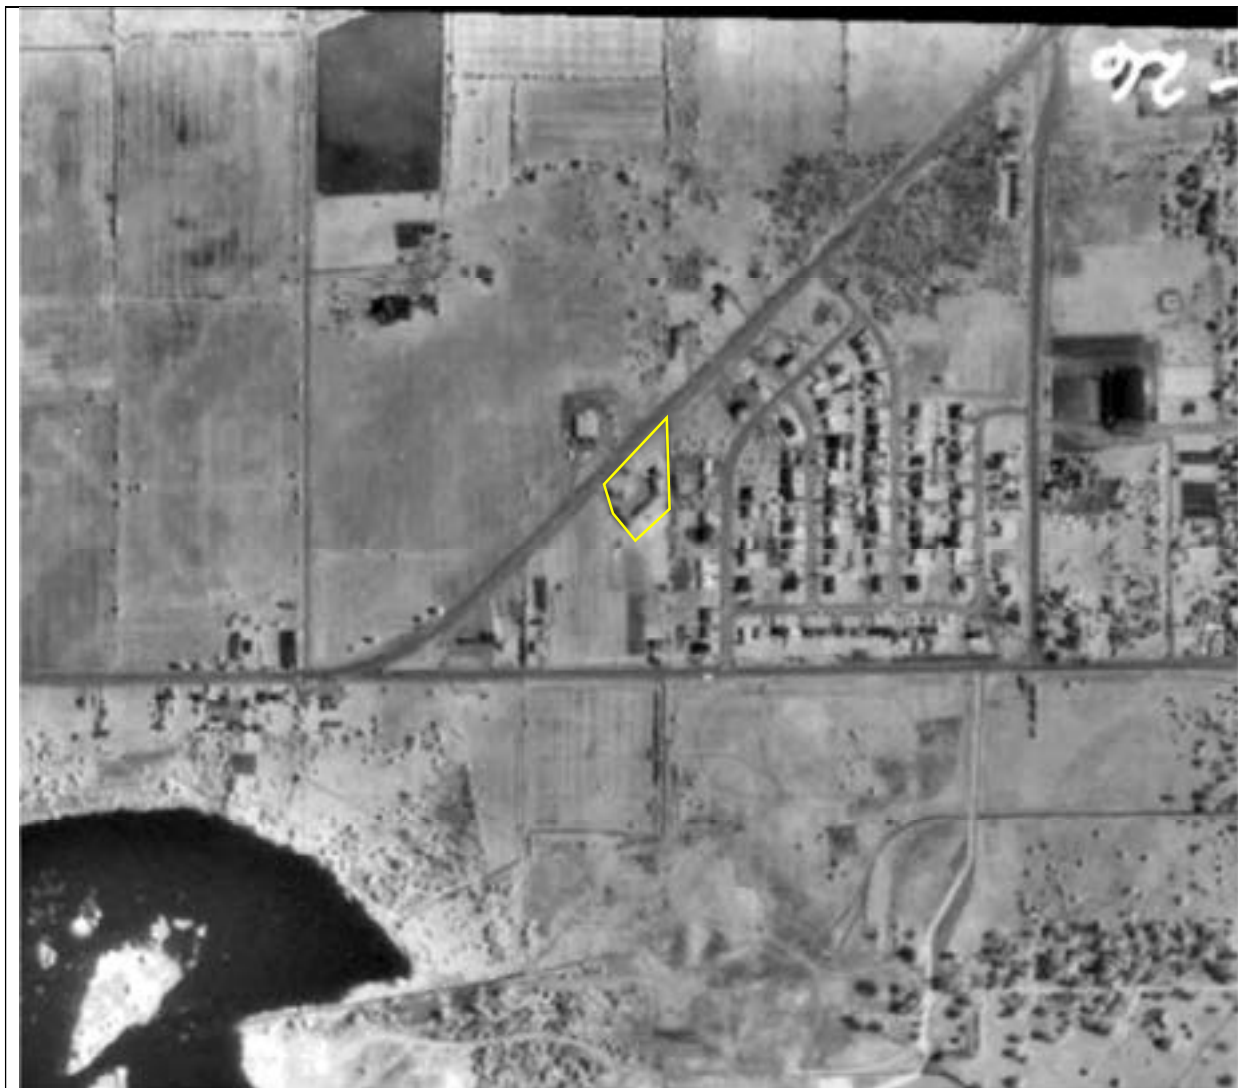
Date	Study Site	Study Area
1973	No significant changes were noted to the study site in the 2013 – 2018 aerial photographs.	The north adjacent property has been developed into a commercial facility with various trucking activities. The east adjacent property and portion of the study area has been completely developed for residential purposes.
1982		No significant changes were noted to the study site in the 1982 aerial photograph.
2000		The north and west adjacent properties have been developed for commercial purposes, as a gasoline service station and automotive part depot store respectively.
2006		No significant changes were noted to the study area in the 2006 - 2018 aerial photograph.
2013		
2018

Photograph No.4-1973

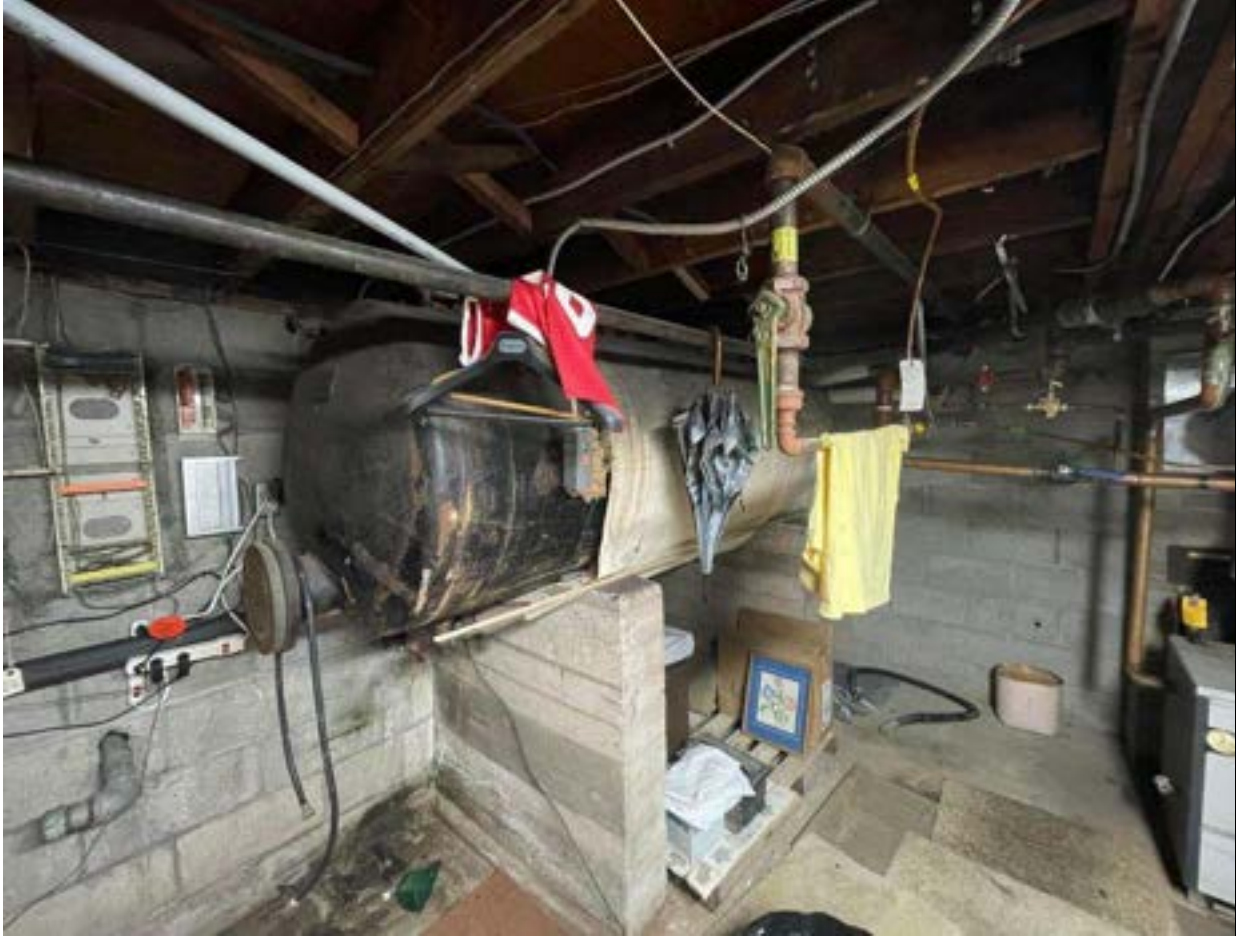
Photograph No. 9 – Underground Storage Tank [AST] located in basement crawl space.

The Phase One ESA identified five [5] areas of potential environmental concern on the Phase One property. NSSL, therefore recommends a Phase Two ESA be completed to investigate the potential for soil and/or groundwater contamination at the study site resulting from historical heating oil use and off-site gasoline service, car wash service, manufacturer, and commercial trucking terminal.

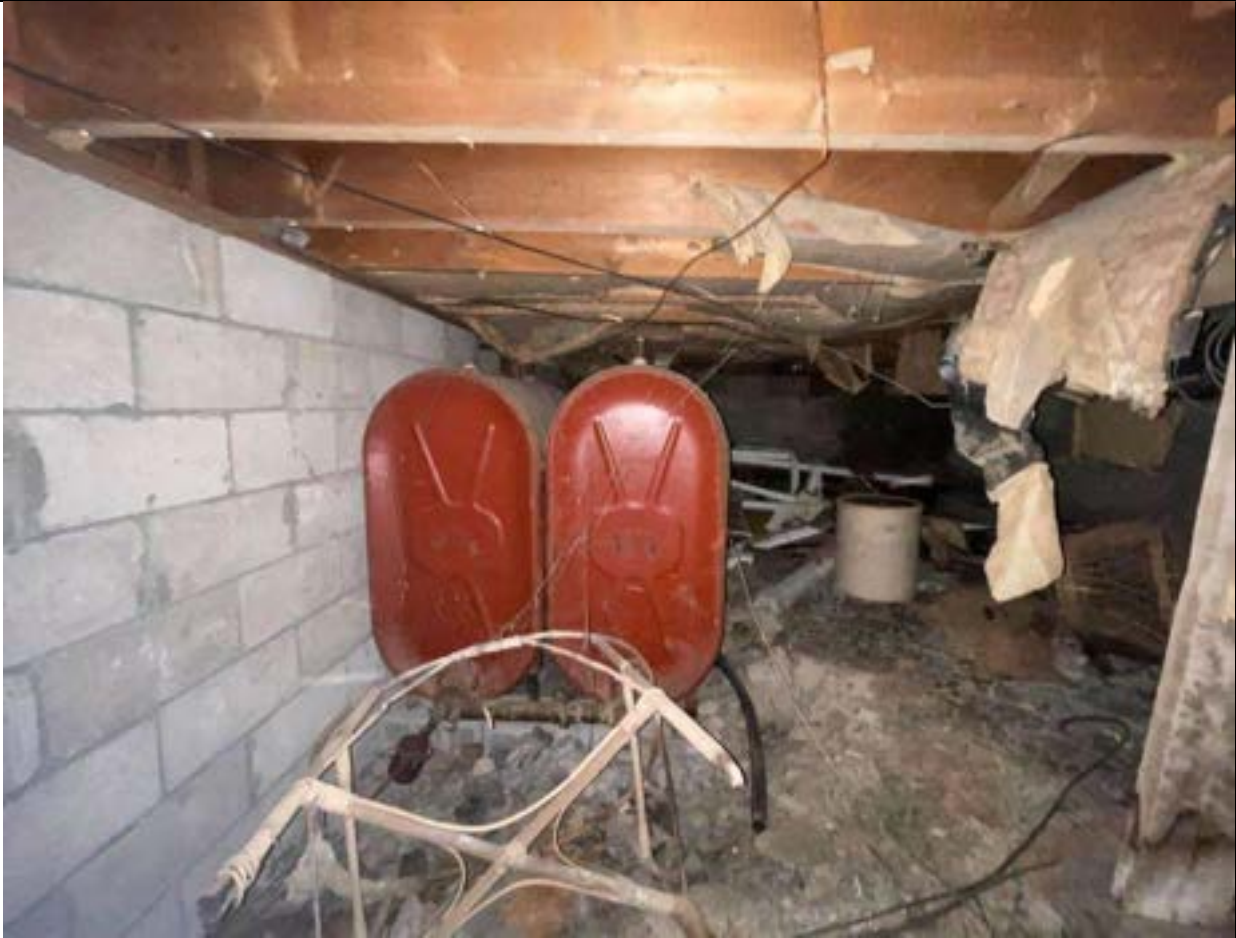
Potential asbestos containing materials were observed within building materials window mastic, stucco, shingles, insulating material surrounding ASTs, floor and ceiling tiles, and cement parge. Asbestos is classified as a designated substance under the Occupational Health and Safety Act and regulated under O. Reg. 490/09.

Photograph No. 10 – Two additional ASTs identified in basement crawl space.

NSSL recommends a designated substance and hazardous material survey be conducted to identify potential lead-based paints, and asbestos-containing materials within the building materials prior to conducting any renovations and/or demolition of the building.

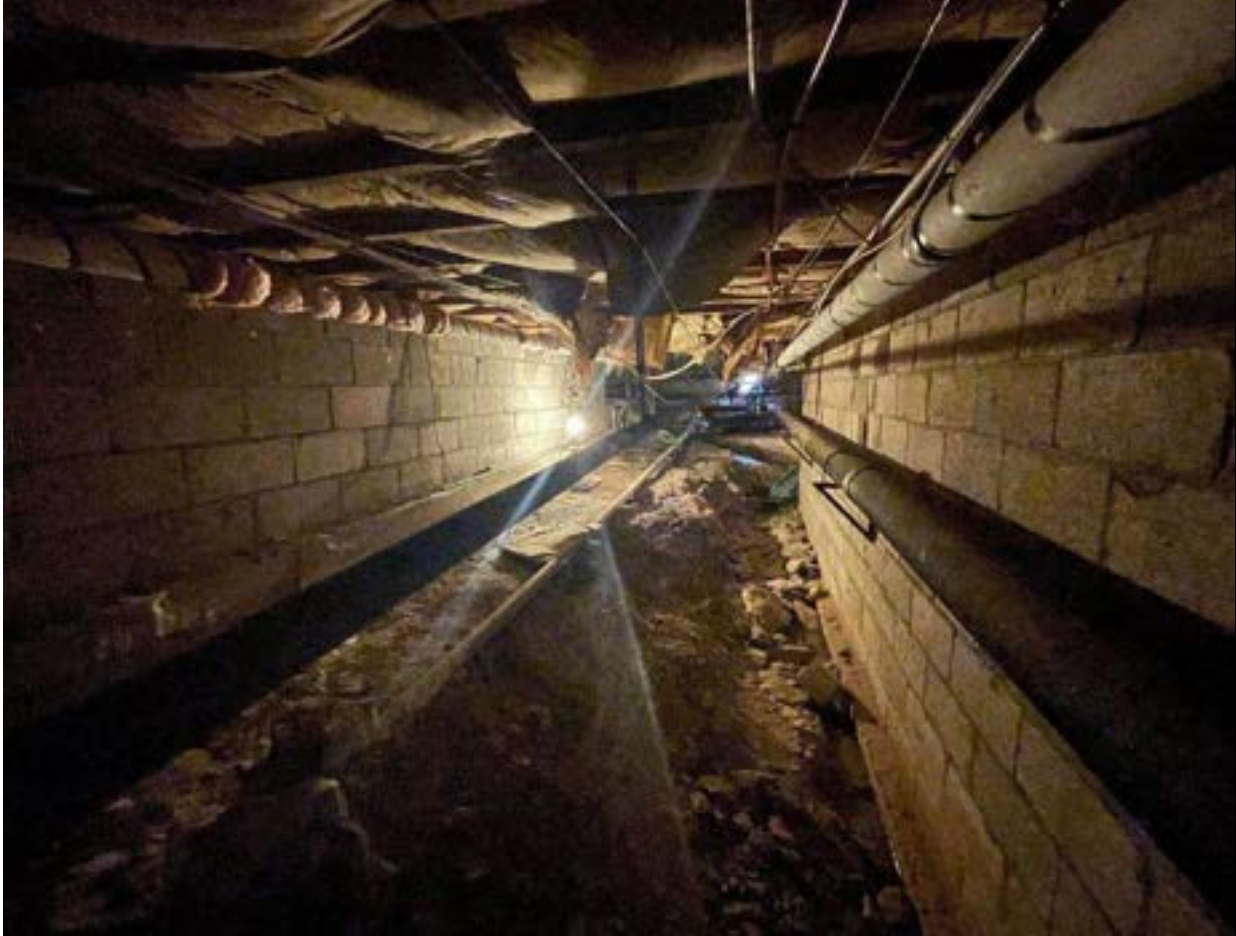
Photograph No. 11 – Basement crawl space with utilities and pipes.

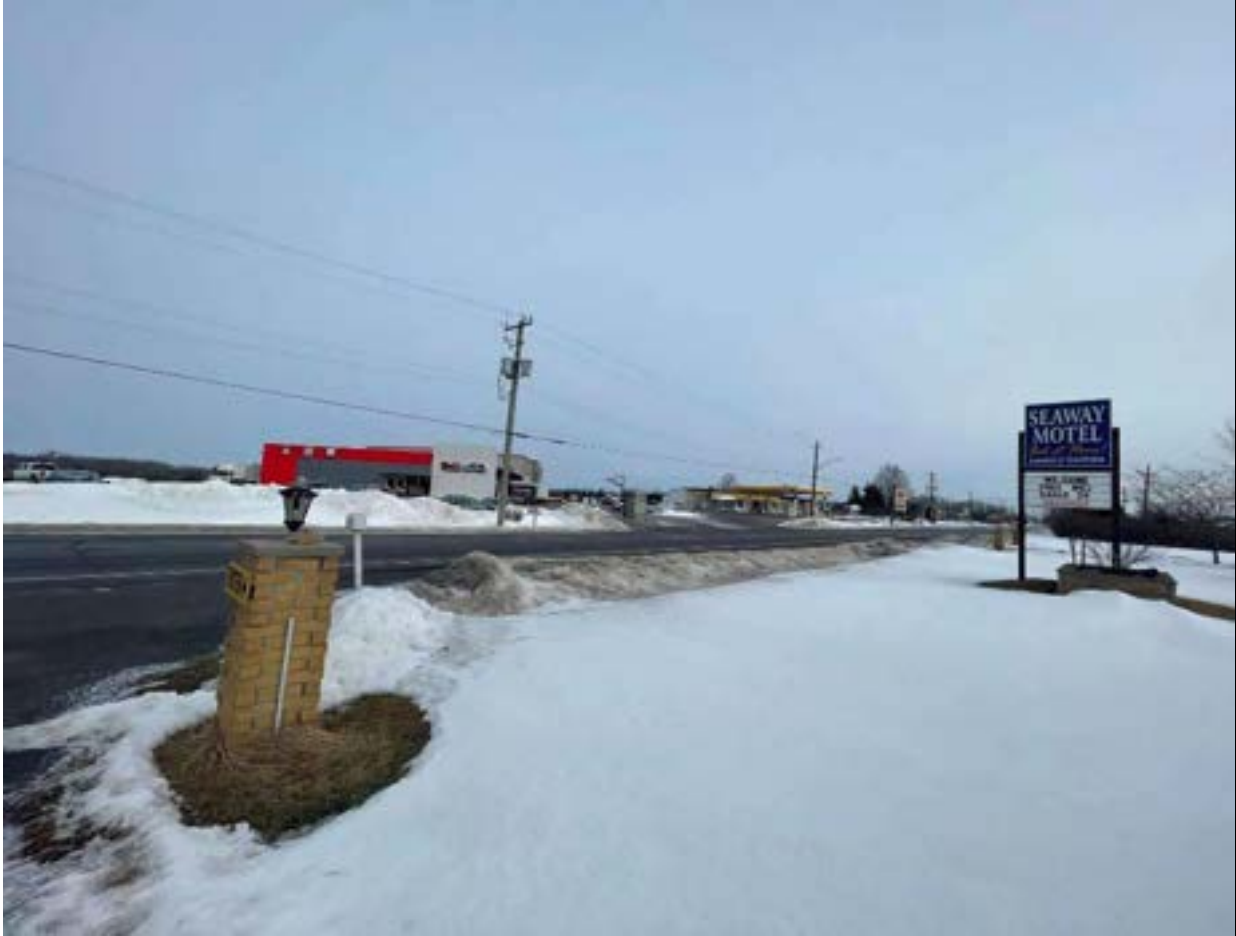
- **PCA-2/APEC-2: #28 Gasoline and Associated Products Storage in Fixed Tanks.** Based on available aerial photographs, a review of the Ecolog ERIS, and observations made during the site analysis, a franchised “Shell Gas Service Station” with associated USTs was identified at 633 Main Street

Photograph No. 12 – North adjacent commercial properties; B&C Truck Centre and Shell Gasoline Service Station.
