Highway 140 Land Holding

Environmental Impact Study

Part Lots 16, 17, 18, 19 Concession 5, Port Colborne, ON

January 31, 2025

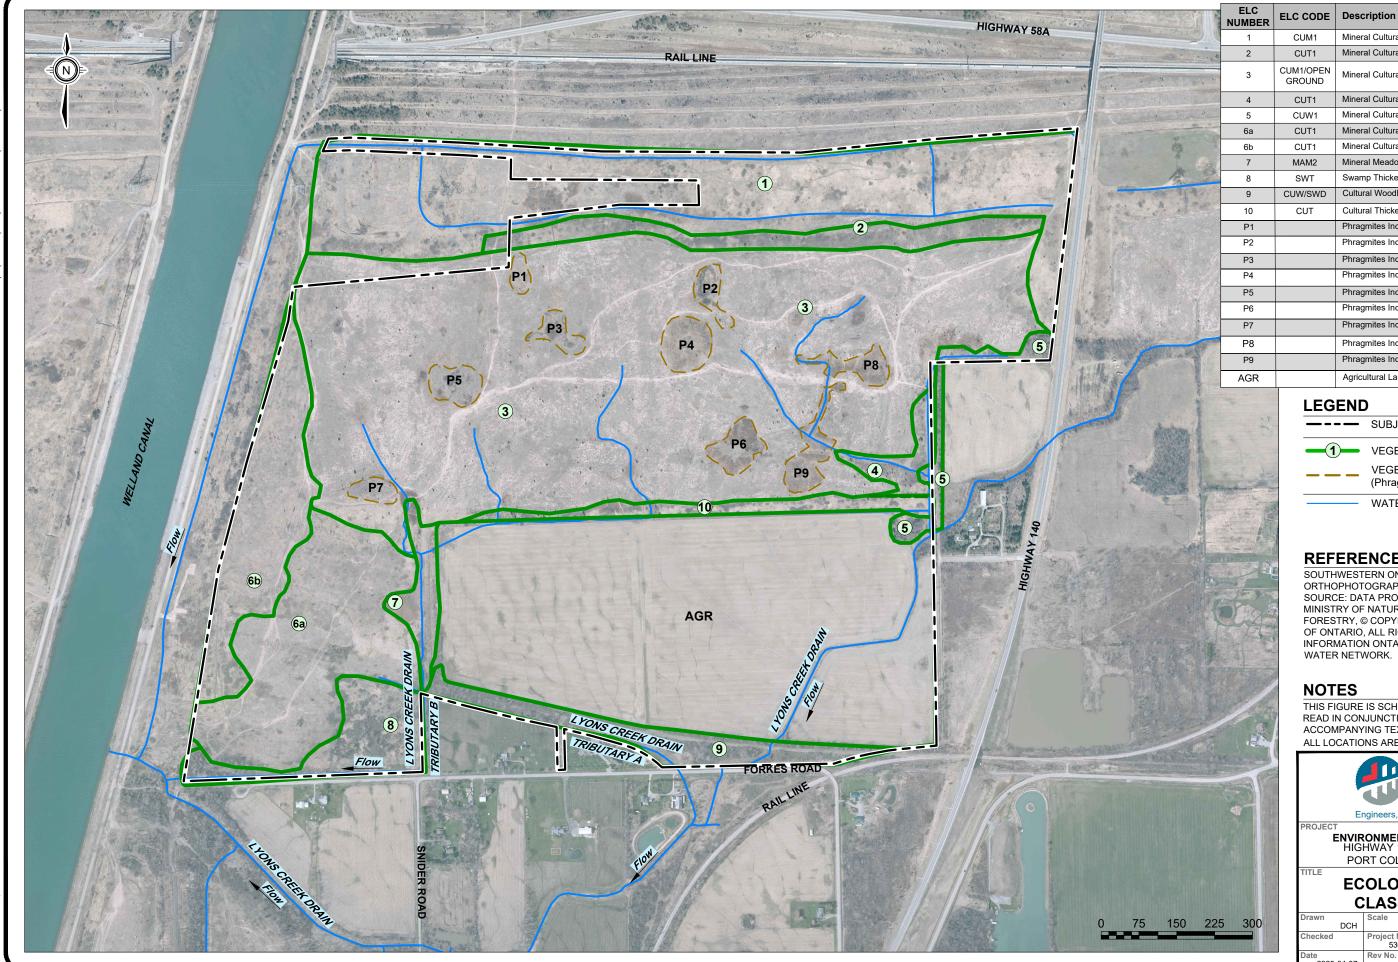
ECOLOGICAL LAND CLASSIFICATION

Mineral Cultural Meadow (27.29ha)

Based on the annotated assessment of community conditions determined through SOFIA, all 10 communities were determined to be of poor floristic quality and minimal natural quality. Given the existing plant species composition, it is expected that the ecological value of the natural heritage communities on the landscape is low.
