Beaver Dam Drain Stormwater Baseline Report

Project No: EWB-189999

City of Port Colborne
Beaverdam Drain Baseline Report

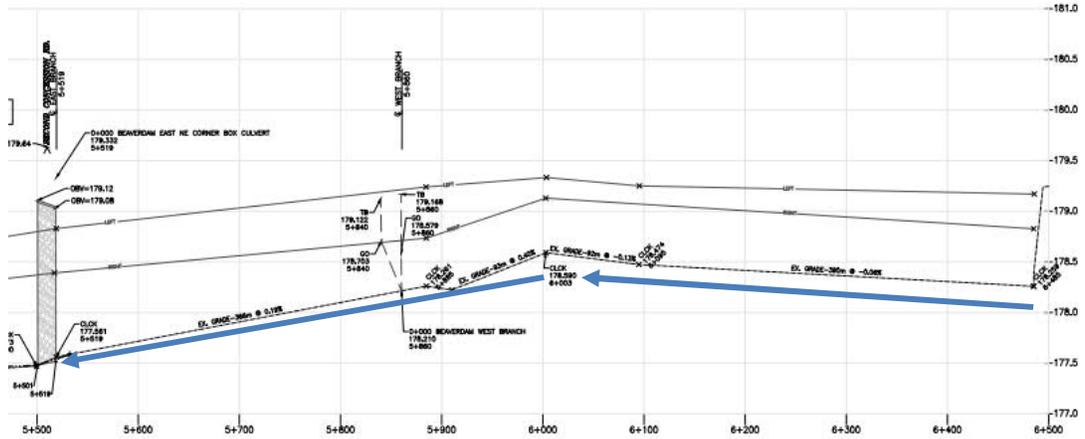
Figure 3 Beaver Dam Grade Above Second Concession Rd.

Upper Main Catchment; influenced by Humberstone Marsh; the upper portion of the main drain proceeds northwards until it appears to lose grade. This section is the connecting portions for the East and West Branch Drains.

The two blue arrows in the figure show the difference in available grade. This exemplifies the East and West Branch Drains as having positive grade drain lines to the main branch but the main branch through the Humberstone Marsh area (North South) does not have a positive drain grade, see Figure 3 Beaver Dam Grade Above Second Concession Rd..

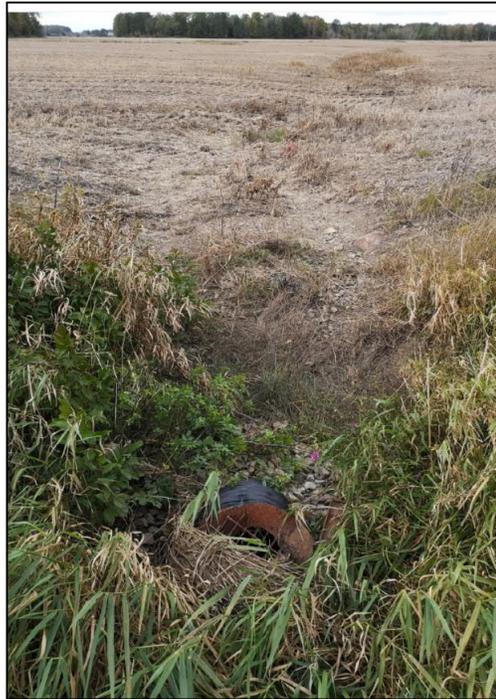
Figure 4 East Branch Extension looking West

East Branch, including proposed extension; Draining lands to the east along Second Concession Rd., the East Branch has a confluence for flows passing to the north crossing a culvert under Second Concession Rd. The City of Port Colborne has requested that the drain be extended to Brookfield Rd. to provide drainage for a newly installed culvert. The intent is to use an existing Tile Drain, PE 250mm as the drain, which outlets to the end of the existing drain culvert at Second Concession Rd.

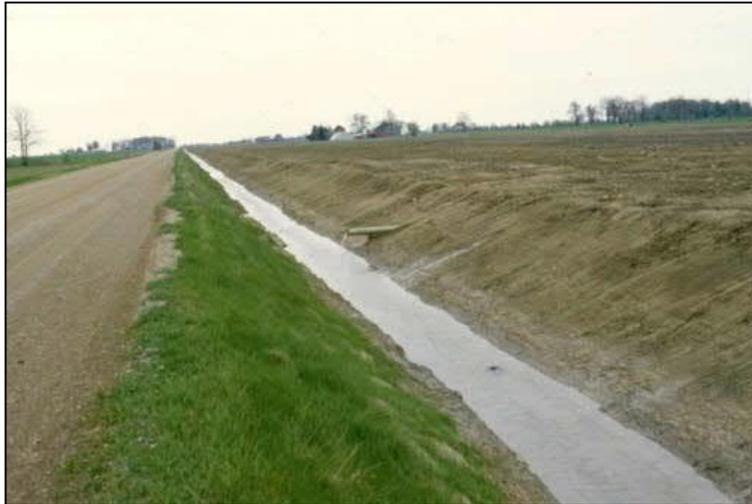
Figure 8 Example of clear drain

The objective of a drain is to provide a clear unobstructed flow with depth to provide adequate private drain connection outlets. The following image exemplifies a traditional “good” drain profile and cross-section with contributory flows from a tile drain connected to the drain.

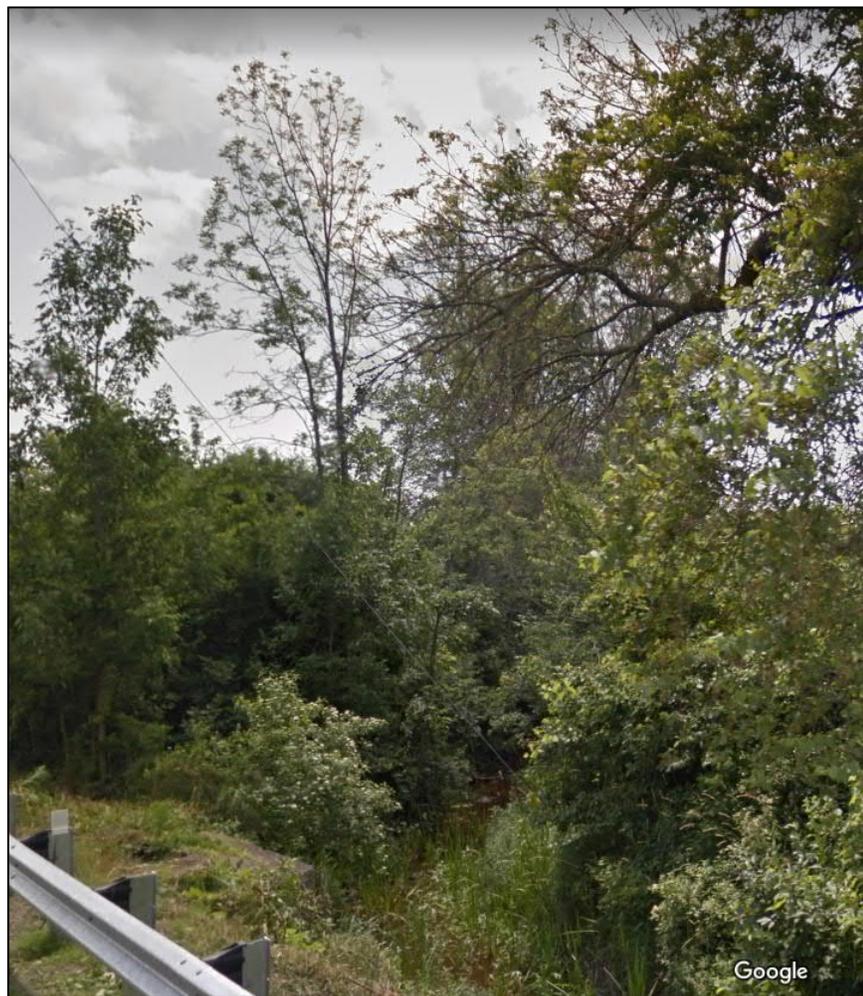
Figure 9 Obstructed drain; Beaver Dam looking Southwest from White Rd.

This flow is obstructed by tree growth within the banks. Bull rushes provide evidence of standing water. The expected performance of the drain based on this approach is compromised and unlikely to perform as designed or expected.

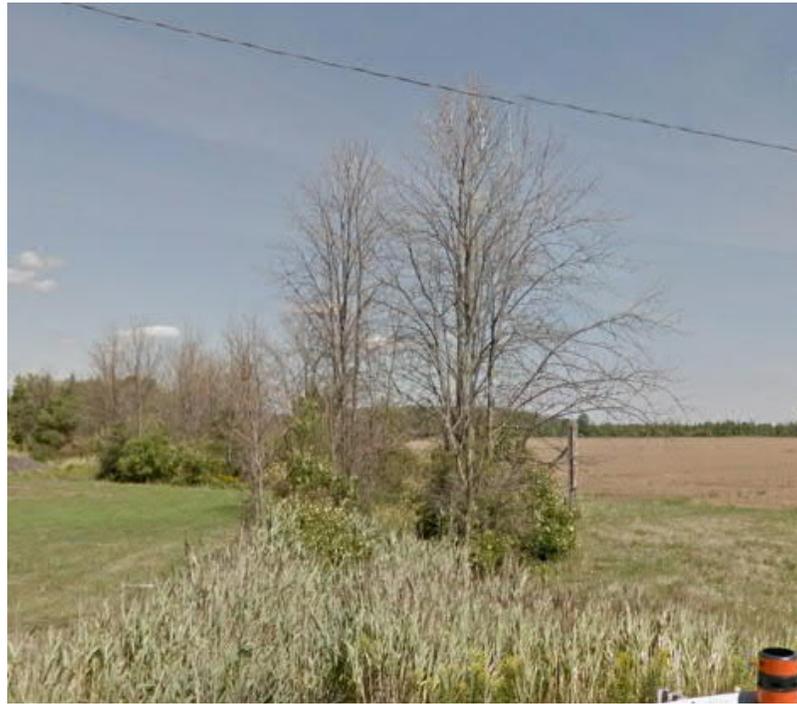
Figure 10 Dead Ash trees within drain banks

The presence of ash trees allowed to grow within the drain banks previously, which are now dead or dying from the emerald ash borer will provide a source of wood debris that may potentially block the drain and cause backwater or other degradations in performance.

The invasive species of ash borer from Asia has decimated Ash trees in southern Ontario. There were significant and numerous opportunistic ash trees that established themselves along the Beaver Dam Drain. These trees are now standing dead with large upper limbs in various stages of decay.

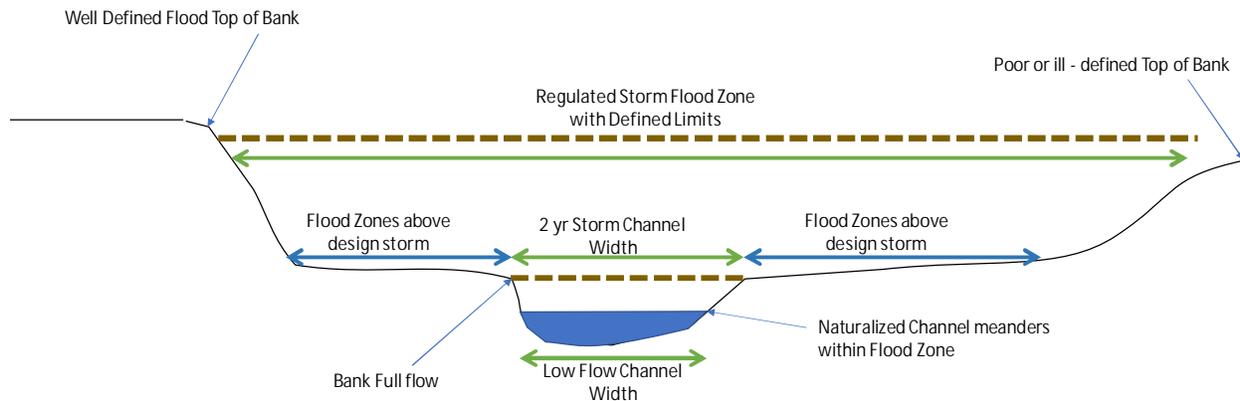
Figure 13 Naturalized Channel cross-section

The following figure illustrates a naturalized channel design approach to a ditch or creek channel.

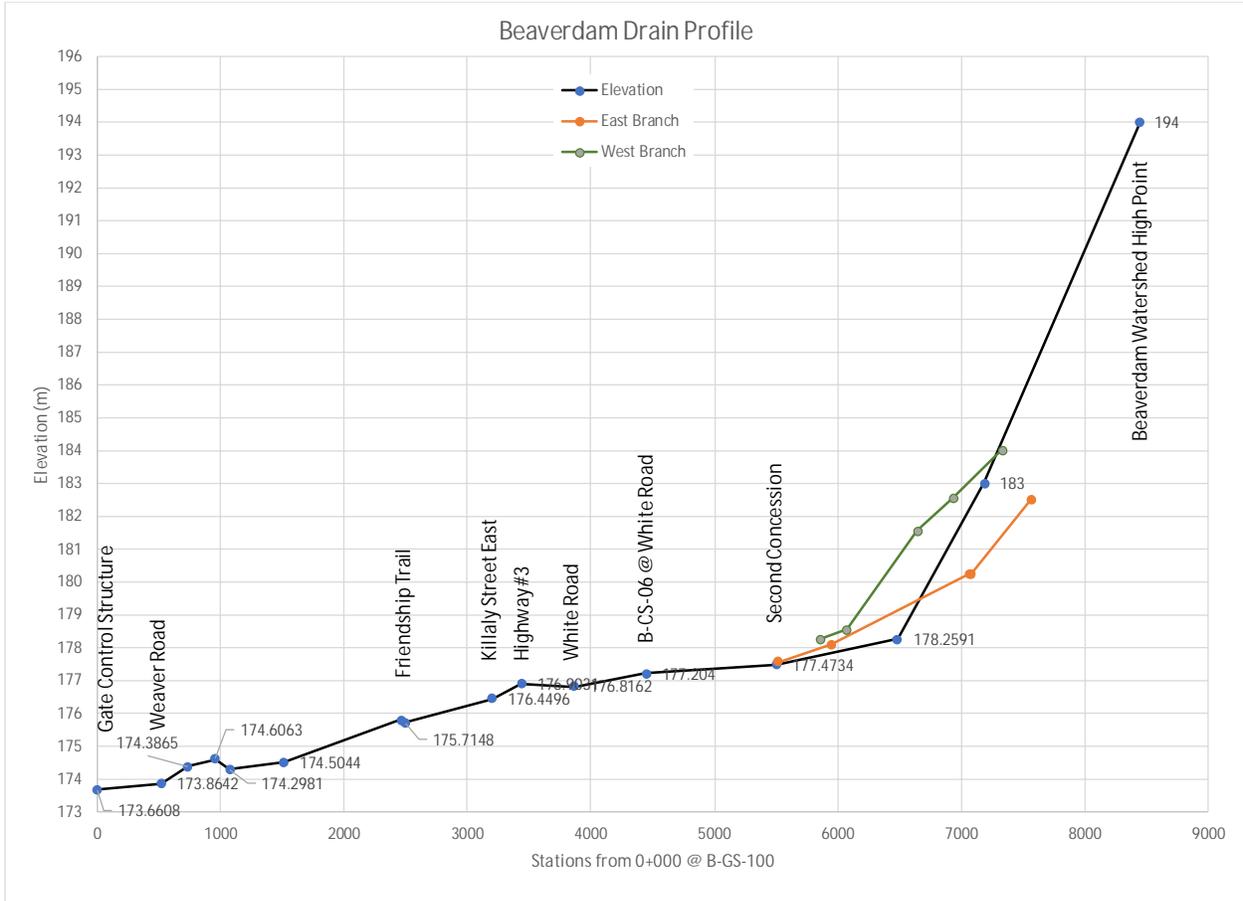
Figure 16 Beaver Dam Drain Profile

0.11% with some segments at 0.19%. The historical existence of rock outcrops within this graded section make achieving grade challenging. An actual survey of rock hasn't not been established; however, it is generally recognized that the drain segment below the Friendship Trail has the rock.

The other significant feature visible in the Drain profile is the grade present in the drain uplands or the source. These are the grades present with overland flow and not channel drain grade that are on average 0.8%. The result is relatively high overland runoff rates in portions of the watershed that once collected into the drain have very low grades to convey the flow. This geomorphologically is a condition for flooding.

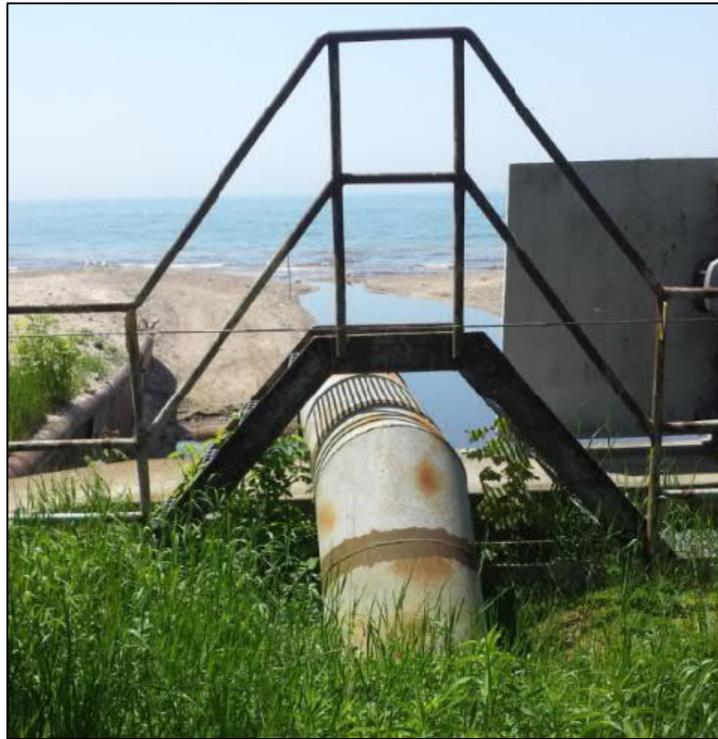
Figure 17 Beaver Dam Outlet

The Beaver Dam outlet is composed a pump discharge pipe, and a control gate structure, shown in following photo. This infrastructure provides a control against a seiche causing short term high lake levels impacting the relatively shallow lower reach.

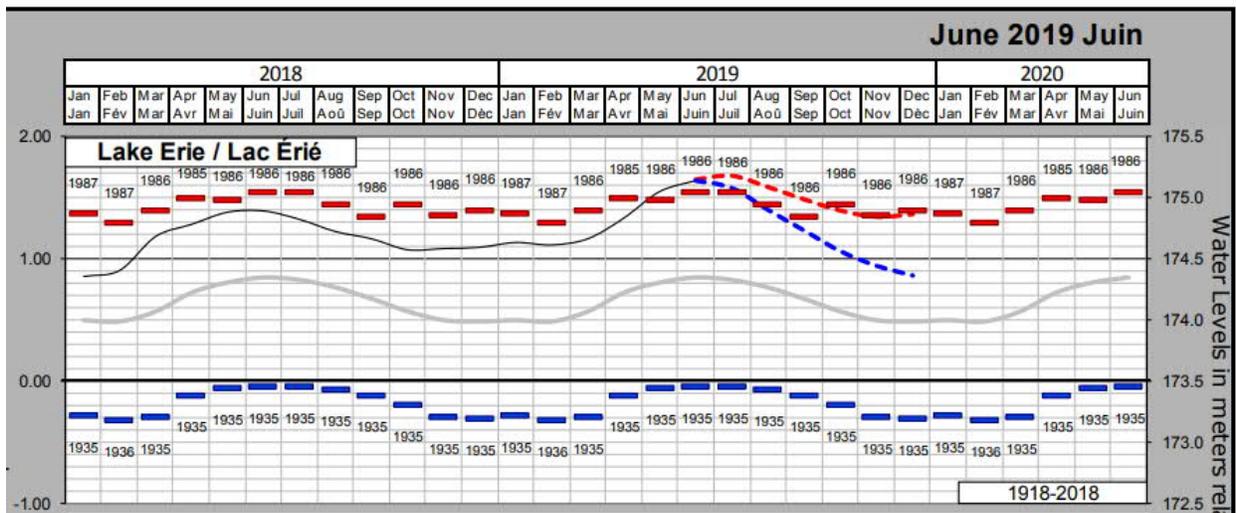
Figure 18 Lake Erie Water Level GC Hydrographic Bulletin, June 2019

From the F&O Government of Canada Water Level bulletin for June 2019, the mean for month of June, 2019 was reported as 175.14 (174.89m last year). This is significantly higher than the Yearly average, 174.35.

The chart shows that for the past two years, water levels are 0.5m above average conditions. Adding wave set up to this further influences the lower reach of the Beaver Dam Drain.

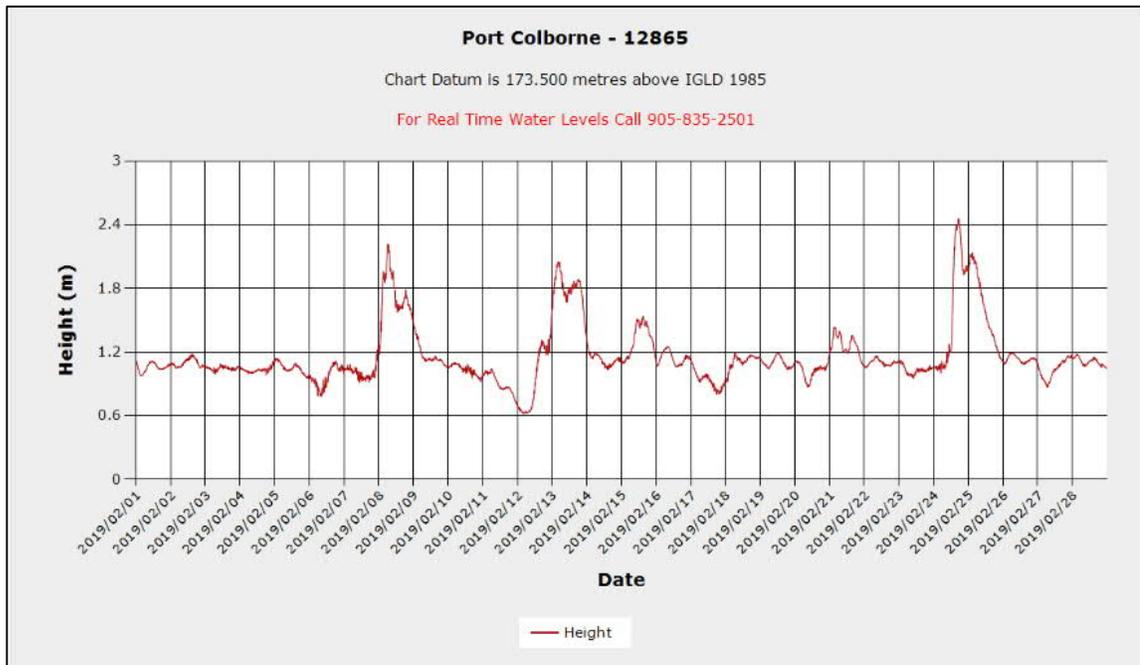
Figure 20 Port Colborne Hydrographic Water Level

The Beaver Dam Control Structure is designed to reduce seiche event water levels from driving back into the drain. The following is the Fisheries and Oceans Canada Water Level monitoring for February 2019 located at Port Colborne.

Chart datum 173.5m + peak observed flow above datum 2.4m = 175.9m.

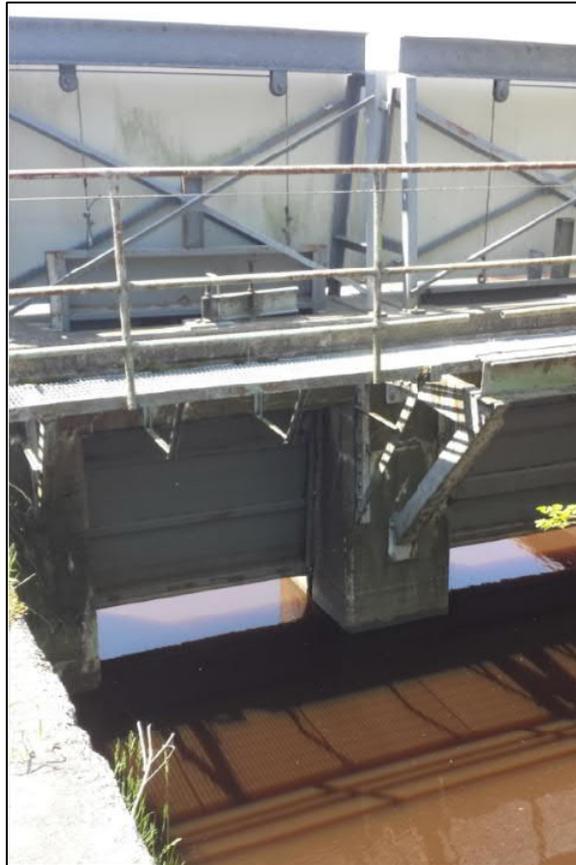
Figure 21 Beaver Dam Control Gate Structure, B-GS-01

This is within 0.7m of the top of the opening for the gate structure shown in the following photo.

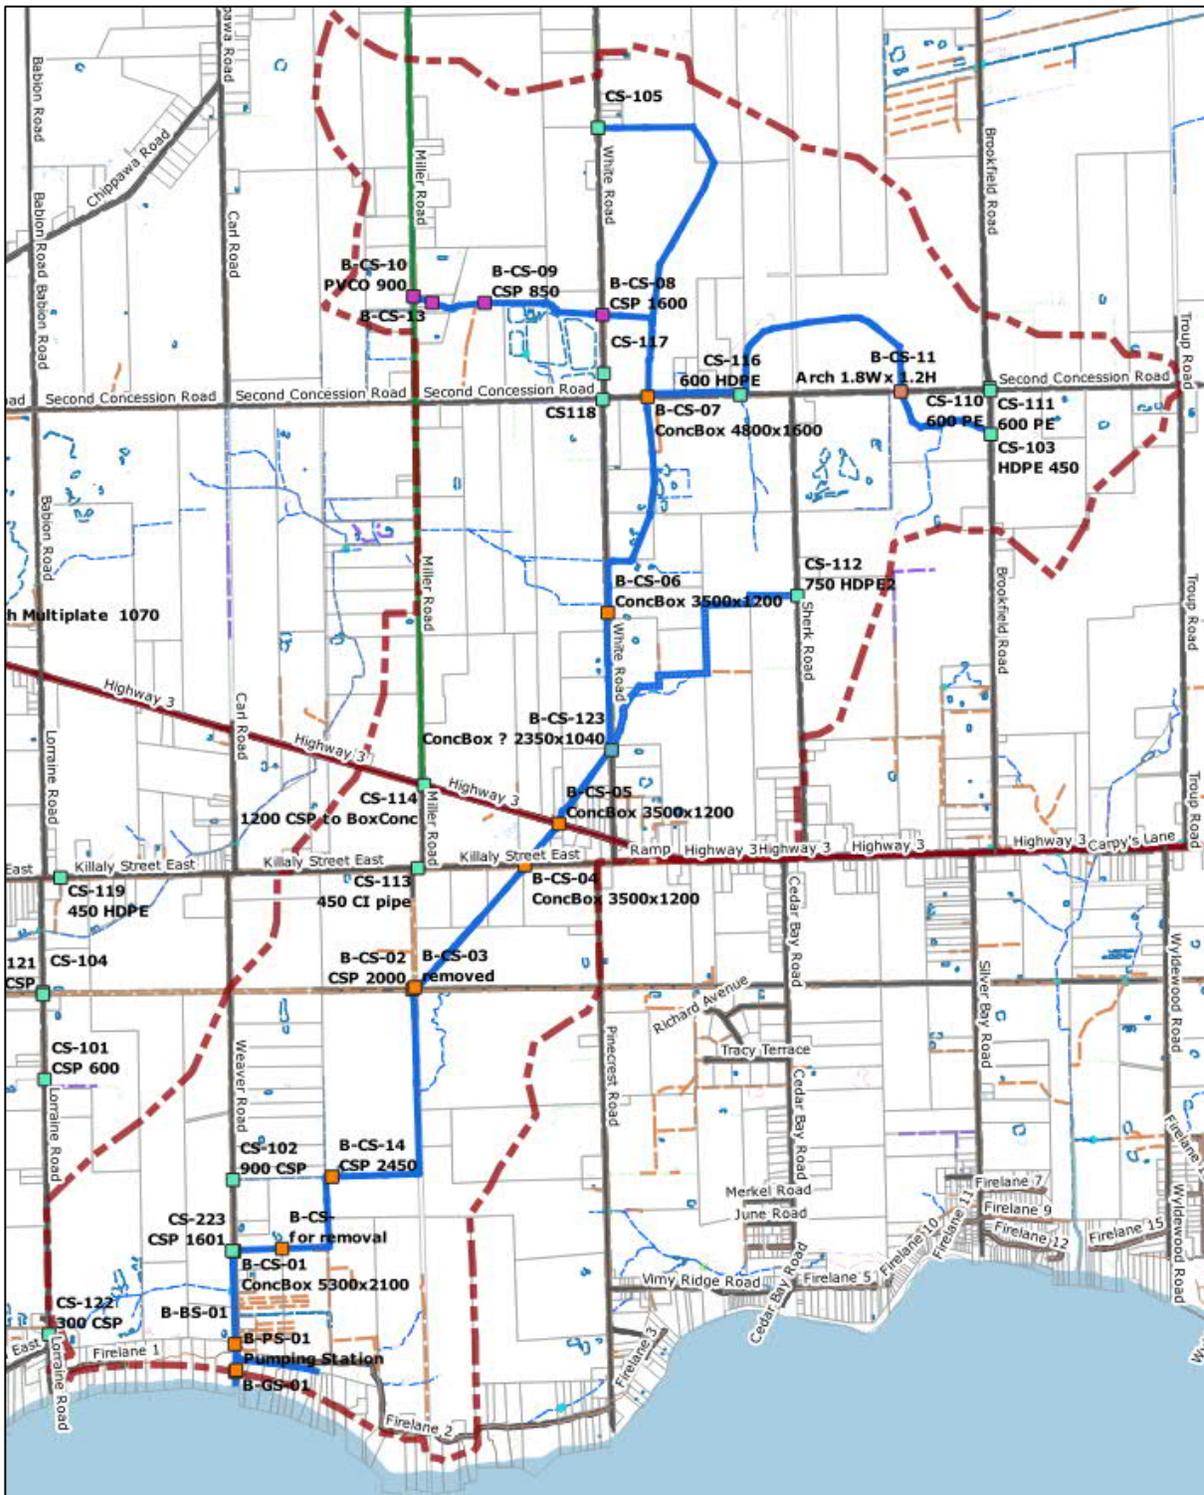
Figure 22 Beaver Dam Bridge and Culvert Drain Structures

There are 10 crossings on the main drain consisting of bridges, culverts or flow controls. The crossings are shown in the following figure and are listed in the following Table. A larger map showing crossings with labels for cross reference is included in Appendix B

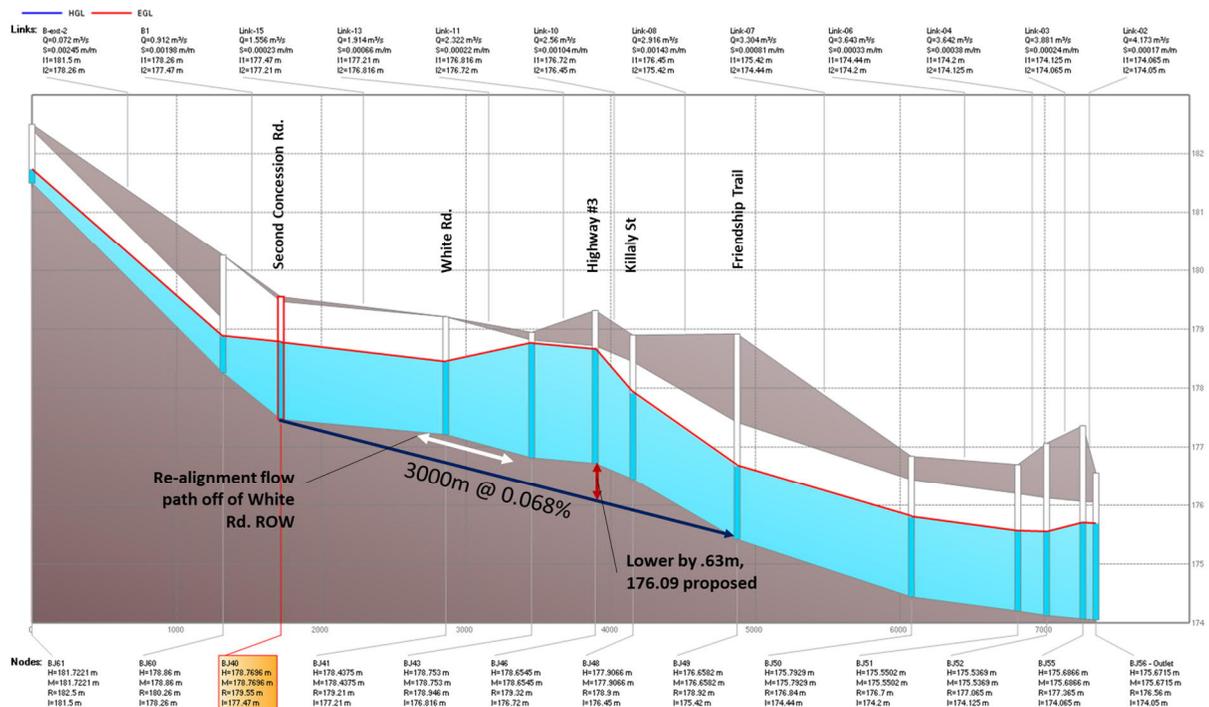
Figure 33 MTO Grade line Option at HWY #3

An email was sent to Mr. Mikhail suggesting that the grade could be lowered through the Highway #3 culvert with a net benefit in overall grade from a South Limit of Friendship Trail and a north limit of the Second Concession. The following figure shows the identified improved grade change.

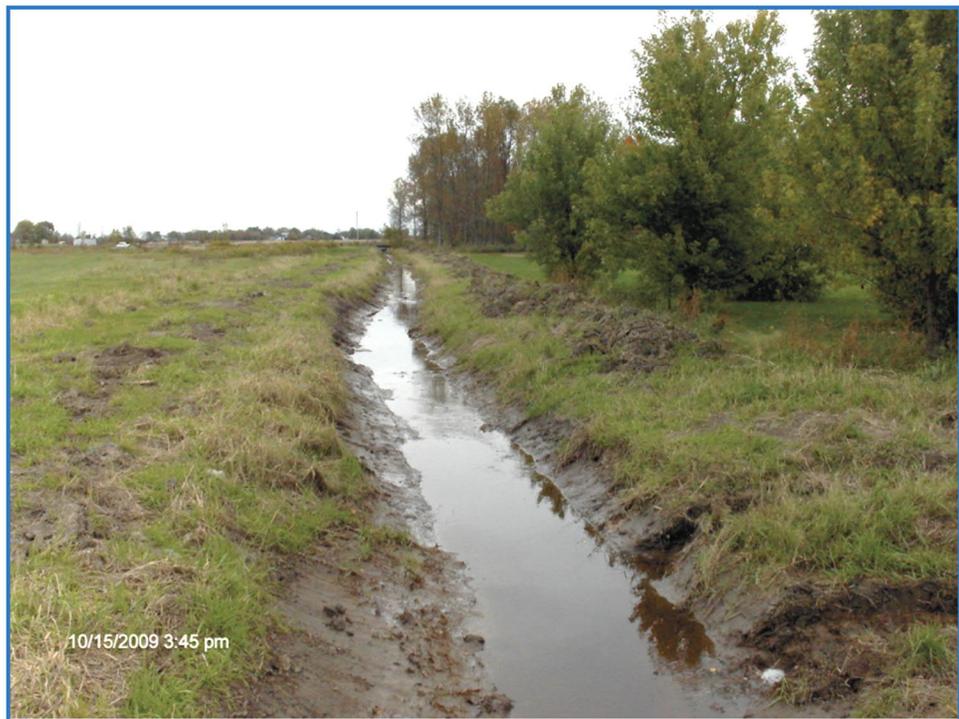
Figure 34 Beaver Dam Maintenance STA 5+260 Upstream

Channel was brushed and had basic bottom grading work done as evidenced in the following images. The first image shows a spoil pile adjacent to the drain from the removed material (no trucking)

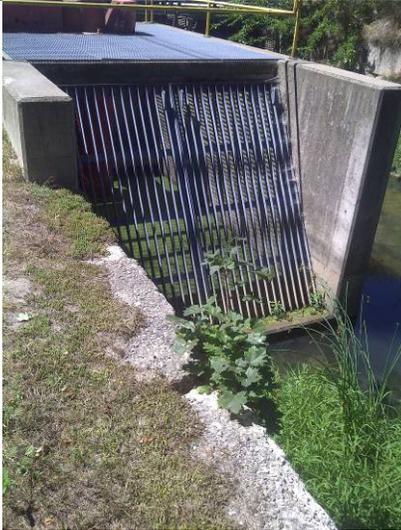
Good condition.
2. Dam Grating - South Side

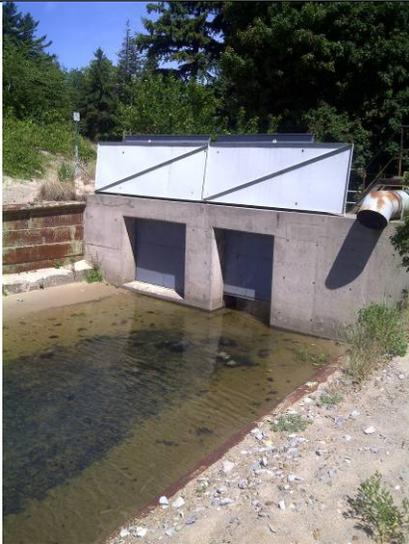
Dam structure appears <u>to be</u> in good condition.

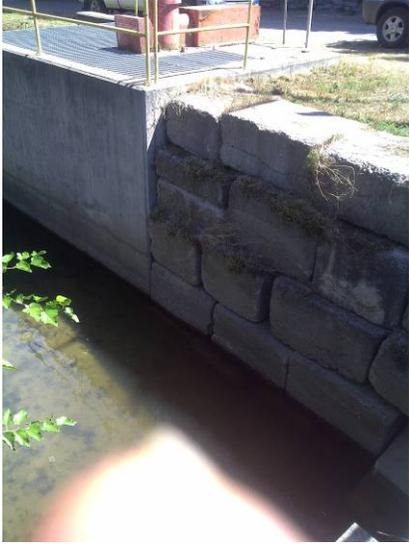
<p>Wall structure appears <u>to be</u> in good condition</p>
<p>ELECTRICAL</p>		
<p>1. Hydro power transformer</p>

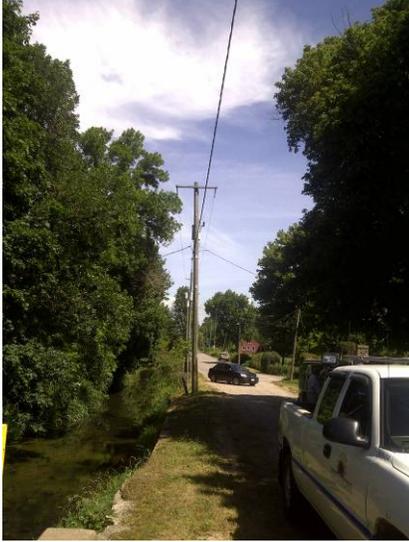
<p>Hydro pole and transformer <u>are</u> in reasonably good condition. Hydro feeds the structure lighting only.</p>
<p>MECHANICAL</p>

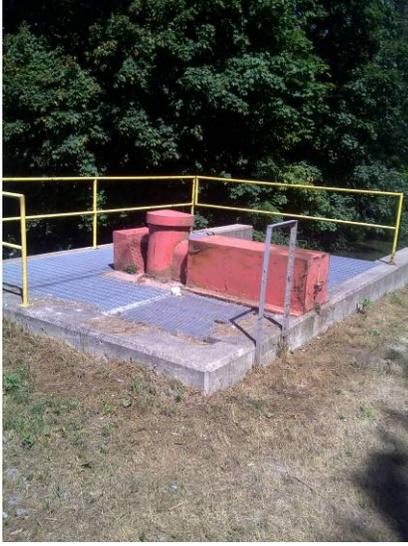
<p>The structure is in good condition. Mechanical pump is functional and in reasonably good condition.</p>
2. Well pump discharge piping & walkway

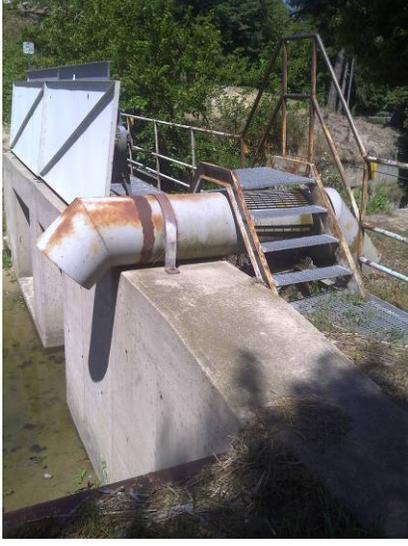
<p>The discharge piping appears to be generally functional and in good condition. The steps structure and walkway are mounted on an angle that could potentially carry a trip hazard. We recommend further investigation to determine if repairs <u>are-is</u> required.</p>

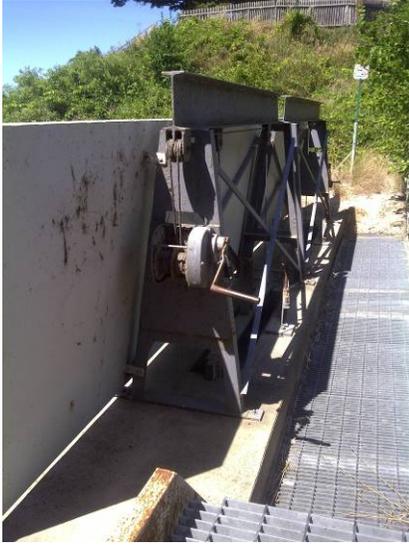
The gates and hoist mechanism is <u>are</u> in reasonably good condition.

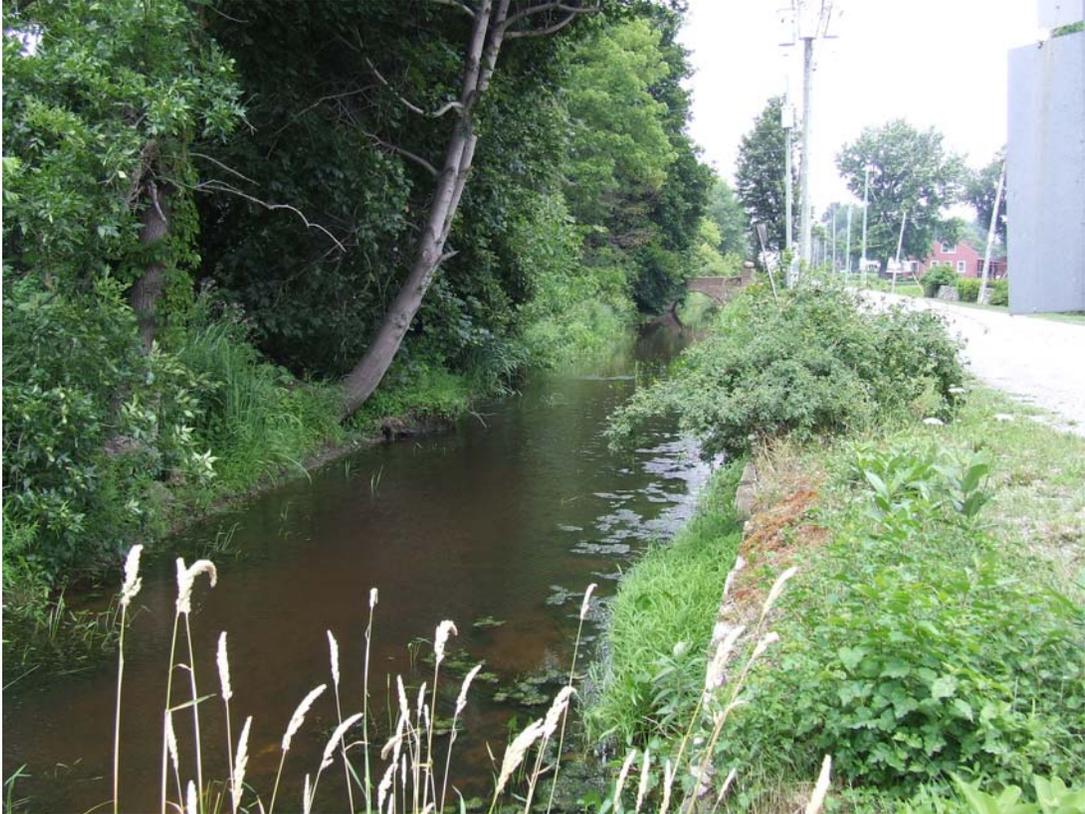
Looking south to lake, showing beach effect:
